SERVICE INFORMATION NO. SI 42-101

GARMIN Software Service Bulletin No. 0849, Revision A
ATA-Code: 34-00

NO.: 0849, Revision A

TO: Diamond Aircraft, Inc.
DATE: 21 January 2009
SUBJECT: G1000 System Software Version 0370.20 Update for G1000-equipped Diamond DA42 Aircraft

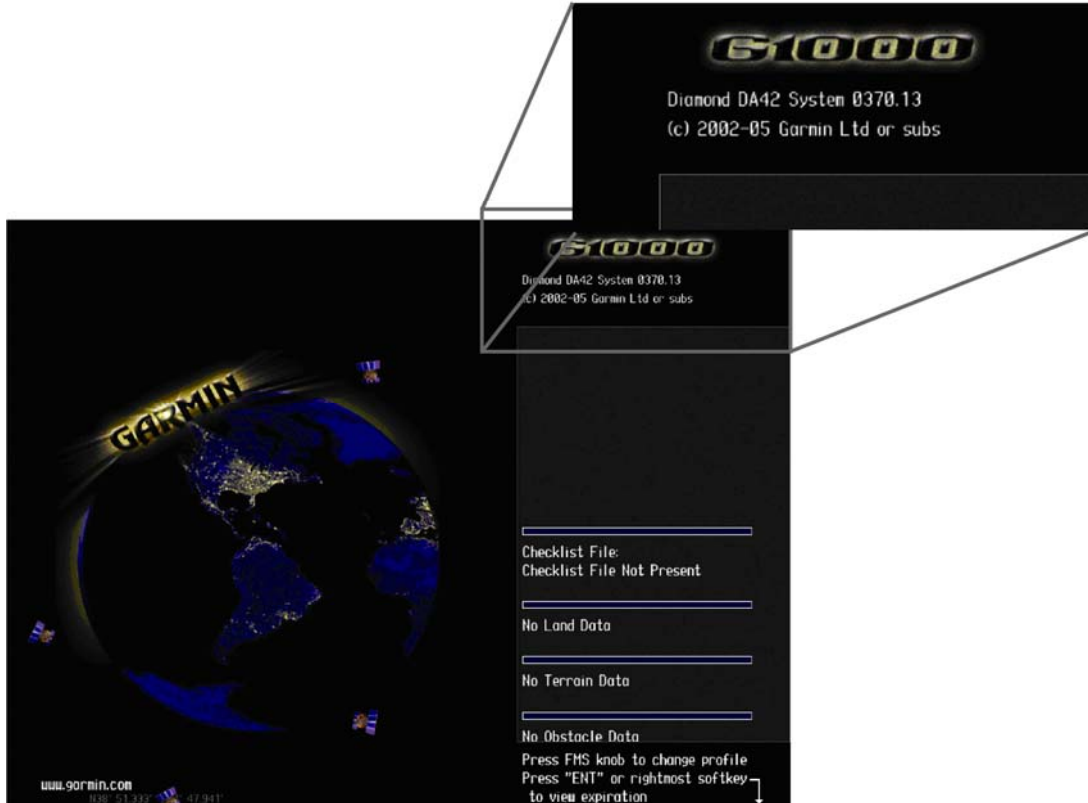
- To identify what G1000 System Software version is installed, do the steps that follow:
 1. In the aircraft, turn the aircraft MASTER switch on.
 2. Look at the MFD power-up screen (see following figure). In the upper right corner, the display shows 'Diamond DA42 System XXXX.XX'.

3. This 'System' number is the System Software Version. It correlates to the G1000 SW Loader Card used to load the software to the system. For example:

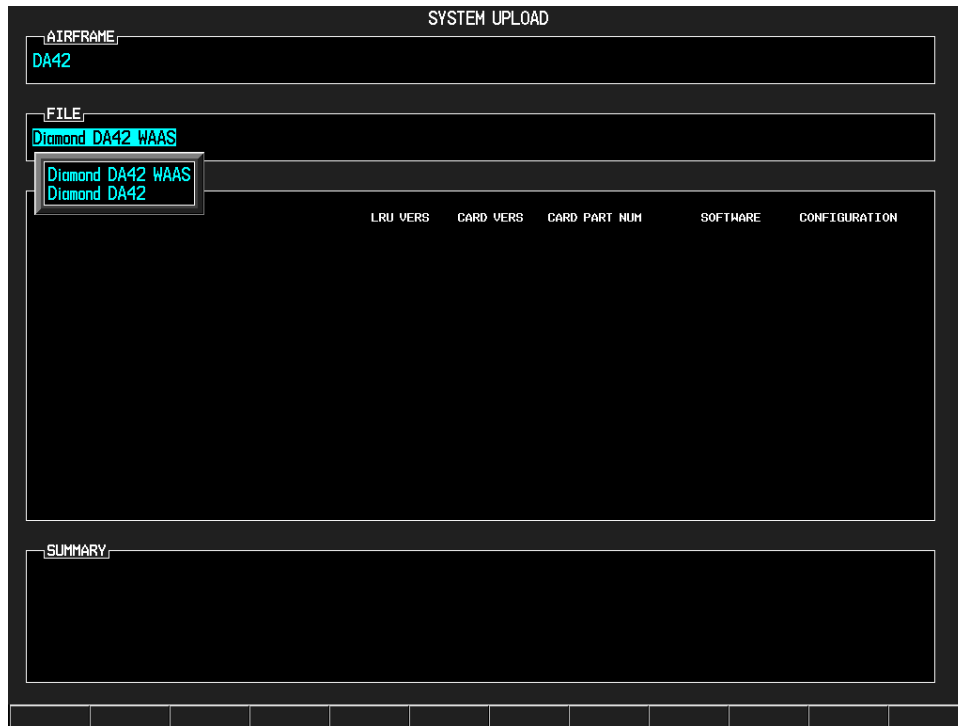
4. Press the ENT key.
5. Using the FMS knob select Diamond DA42 WAAS or Diamond DA42 in the FILE field, depending on your current system.

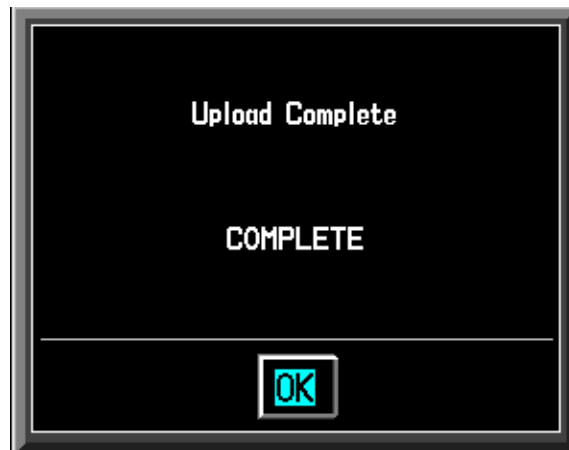
10. Once all files have been successfully loaded, press the ENT key to acknowledge the Upload Complete prompt.

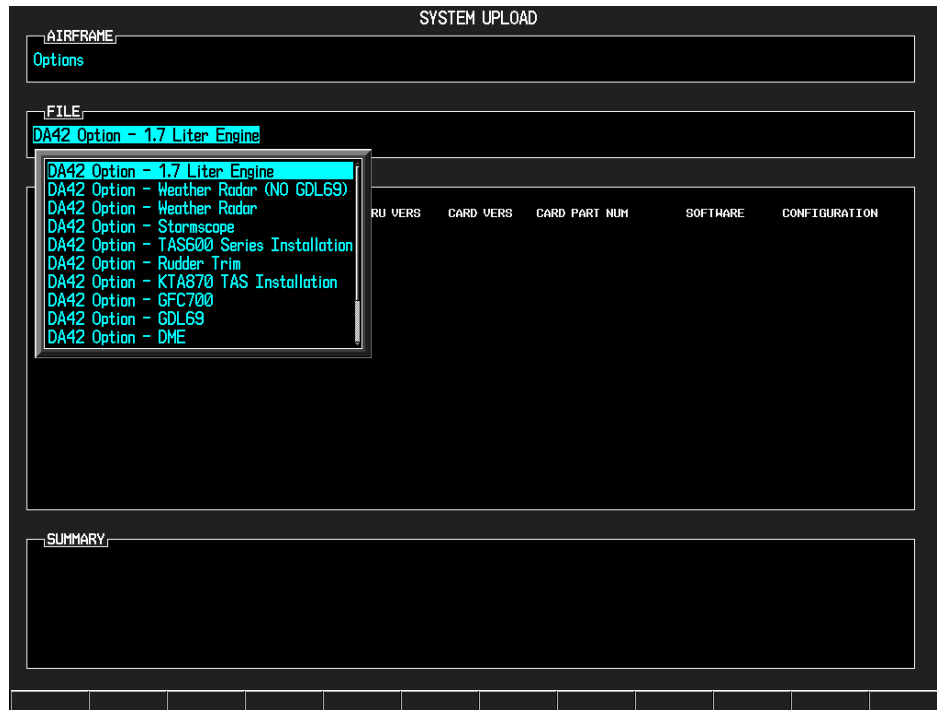
4. Press the ENT key.
5. Using the FMS knob select the appropriate option and press the ENT key.

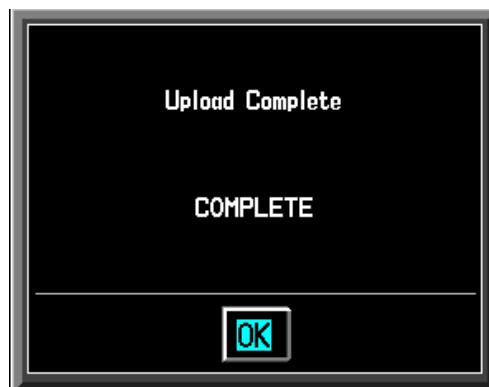
6. Press the CHK ALL softkey.
7. Press the LOAD softkey, to begin the software and configuration loading process.
8. Press the ENT key to acknowledge the Upload Complete prompt.

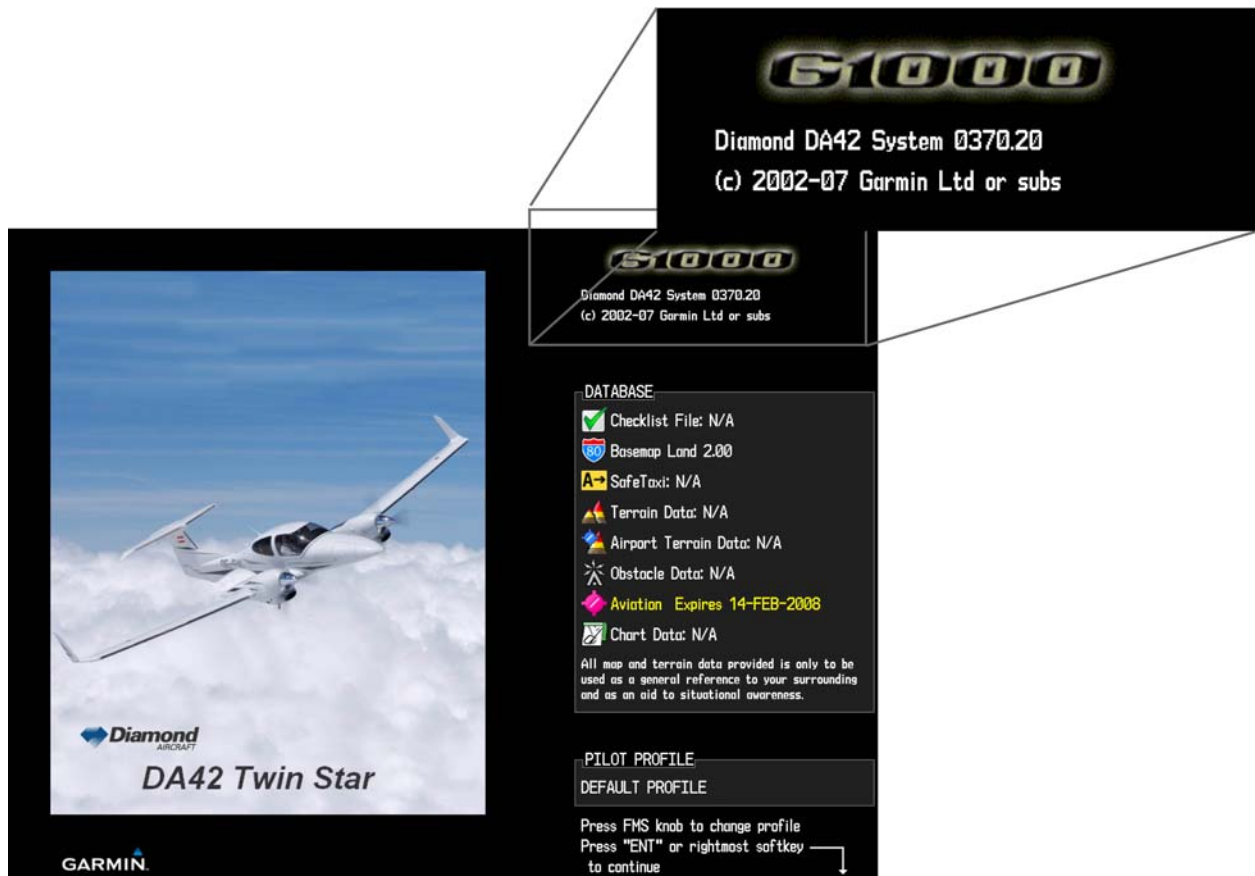
1. Look at the MFD power-up screen. In the upper right corner, the display shows 'Diamond DA42 System XXXX.XX':

2. This 'System' number is the System Software Version. It correlates to the G1000 SW Loader Card used to load the software to the system:

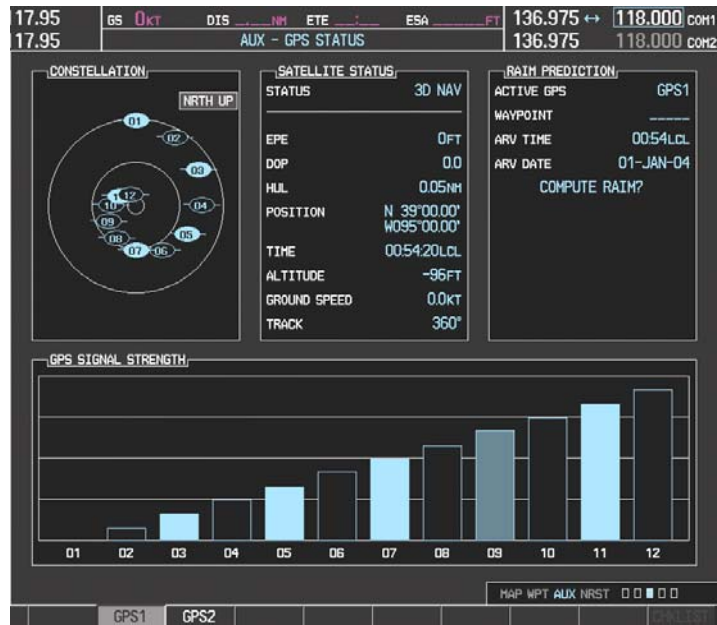
13. The GIA 63 units should normally acquire a 3D GPS navigation solution within 5 to 10 minutes of startup, provided the aircraft is outside (or indoors with a GPS repeater). Select the AUX – GPS STATUS Page on the MFD. Two softkeys on the bottom of the display allow the user to toggle between GPS 1 and GPS 2. Verify that both receivers show 3D Navigation on the MFD.

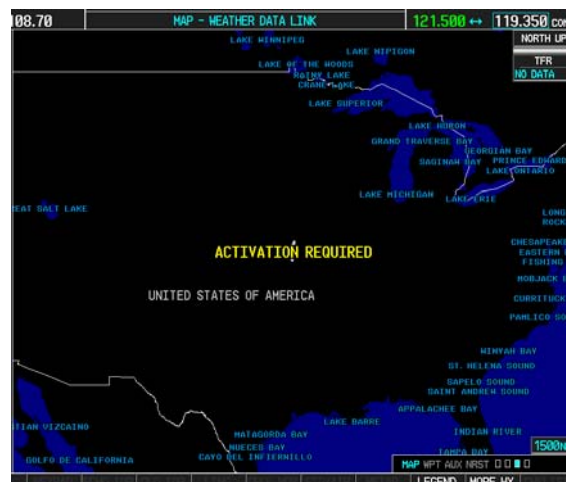
1. Using the small FMS knob, verify the Map – Weather Data Link page can be displayed on the MFD.

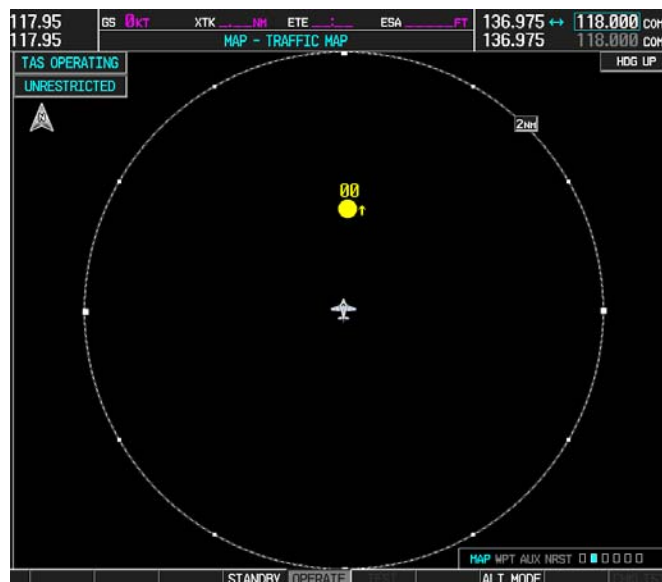
1. Using the small FMS knob, verify that the upper left corner of the Map – Traffic Map page on the MFD displays “TAS OPERATING”.

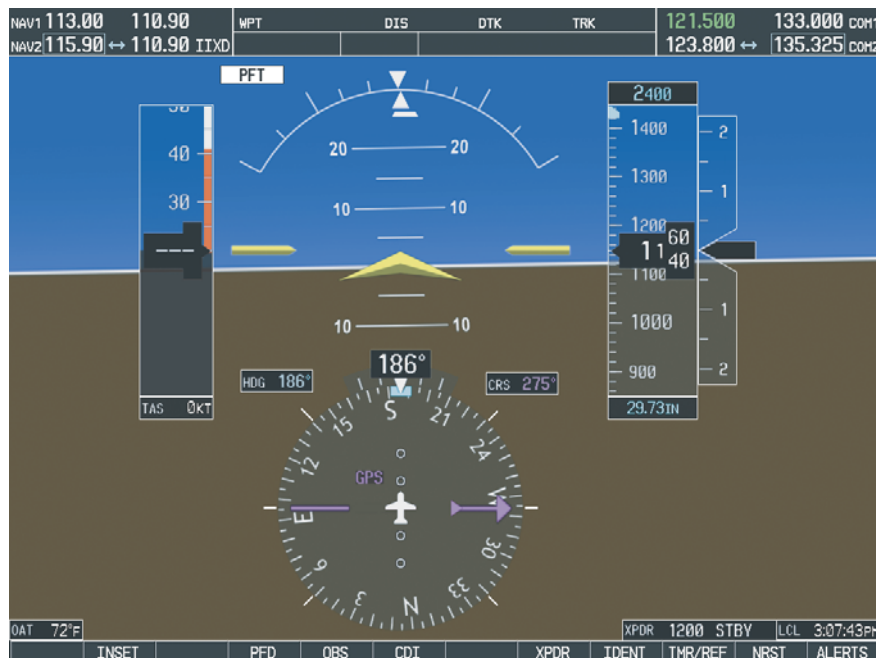
A red 'AFCS' (AFCS) annunciation will be displayed until both GIAs, the AHRS, and the autopilot servos are online. The red 'AFCS' annunciation will then be replaced by a white 'PFT' annunciation.

2. Verify that a white 'PFT' annunciation is displayed on the PFD, as shown in the following figure.

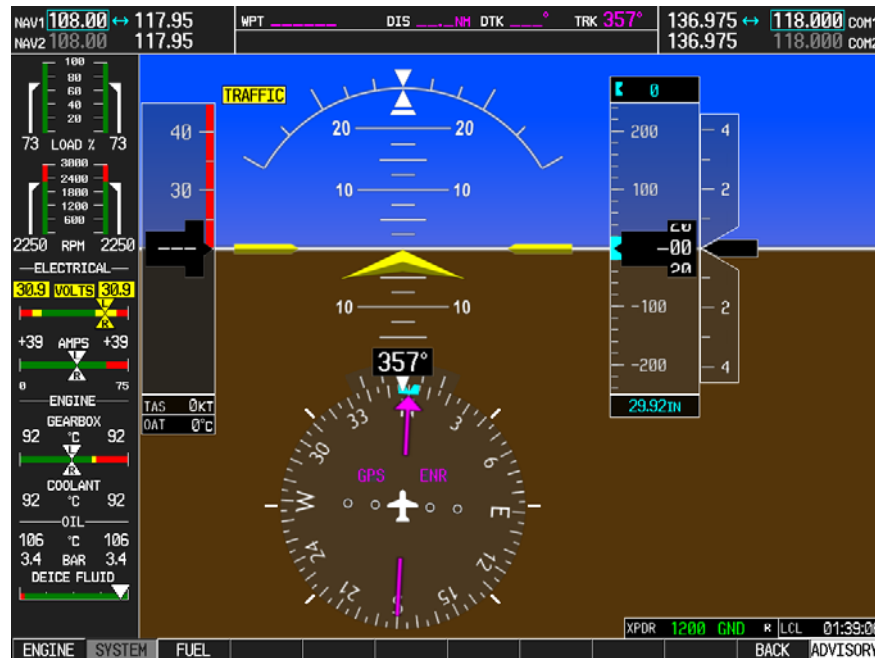
1. For aircraft with the Deicing system installed, verify that the lower left corner of the System Display on the PFD displays "DEICE FLUID".
