SERVICE INFORMATION NO. SI-42-141

GARMIN Service Bulletin No. 1031, Revision A
ATA-Code: 34-00

NO.: 1031 Revision A

SUBJECT: G1000 System Software Version 0370.22 Update for G1000-equipped
Diamond DA42 Aircraft

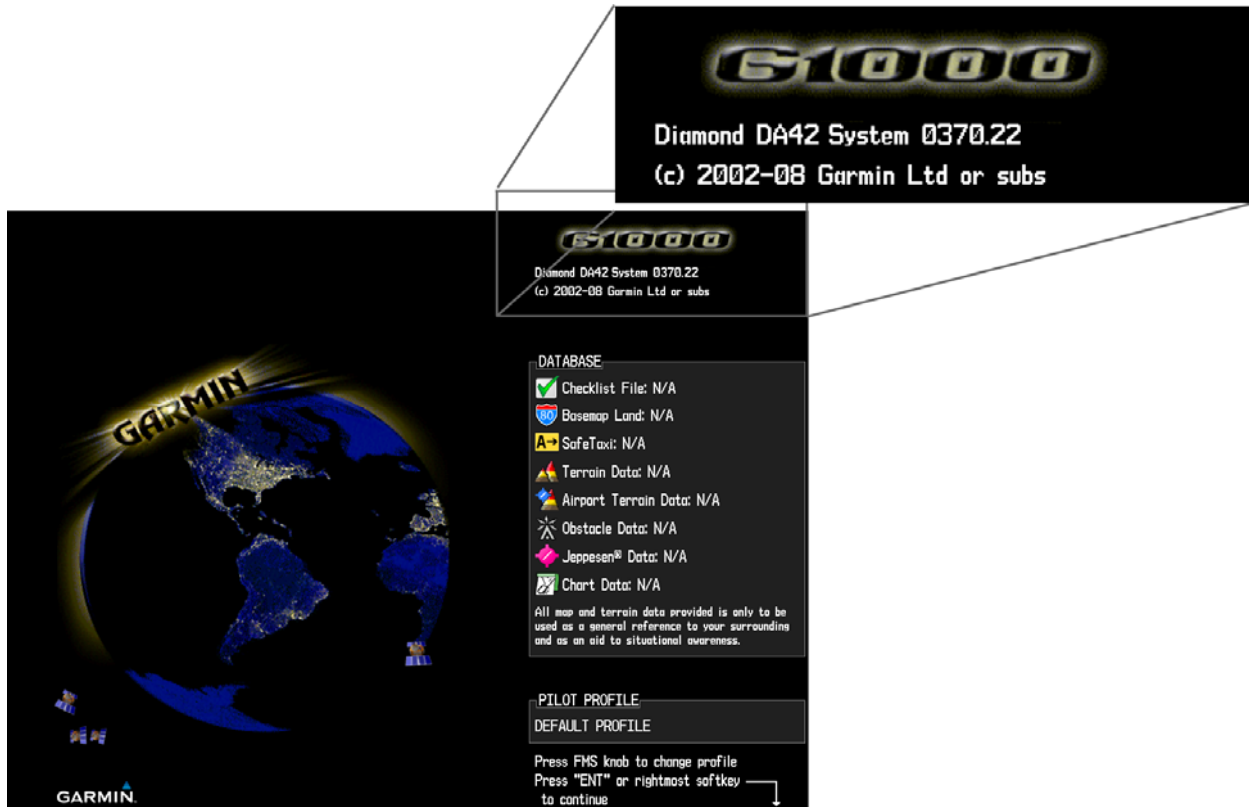
To identify the installed G1000 System Software version, do the steps that follow:

1. In the aircraft, turn the aircraft Electrical Master switch on.
2. Look at the MFD power-up screen (see following figure). In the upper right corner, the display shows 'Diamond DA42 System XXXX.XX'.

3. This 'System' number is the System Software Version. It correlates to the G1000 SW Loader Card used to load the software to the system. For example:

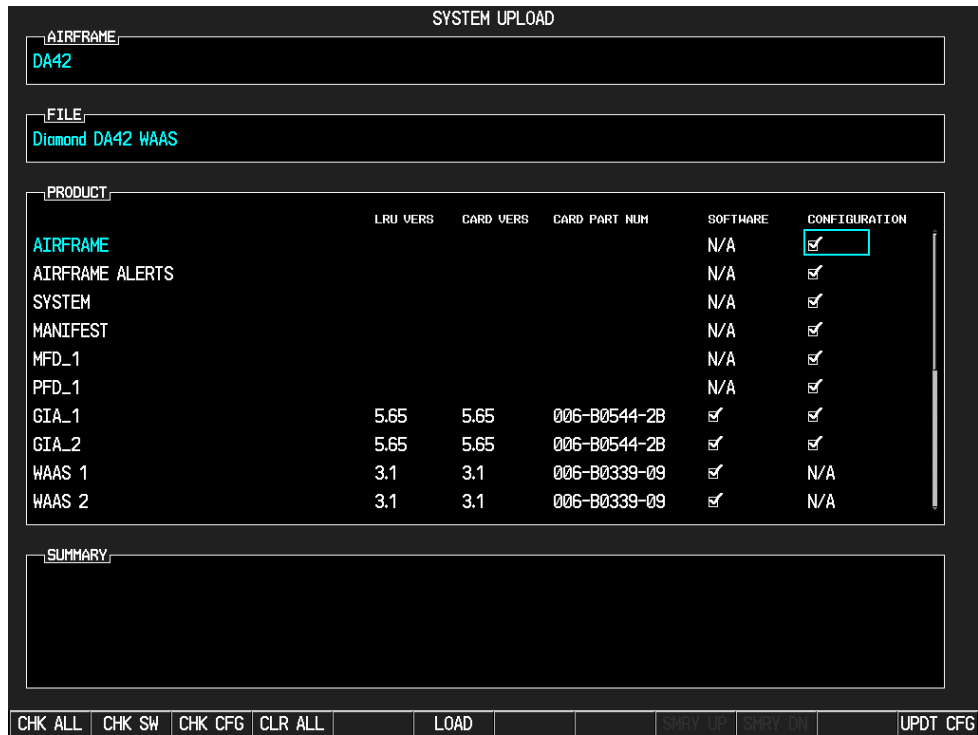
7. Press the CHK ALL softkey.
8. Press the LOAD softkey to begin the software and configuration loading process.

9. Monitor the status of the upload process.

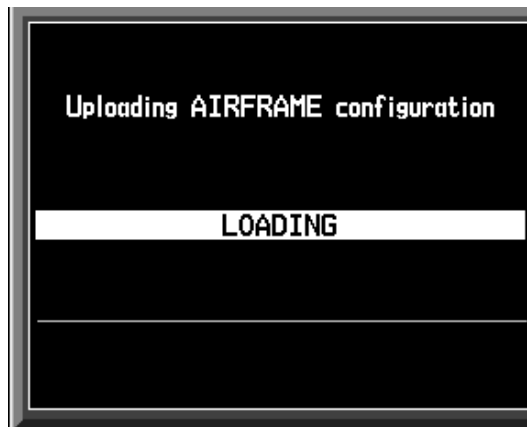
10. Once all files have been successfully loaded, press the ENT key to acknowledge the Upload Complete prompt.

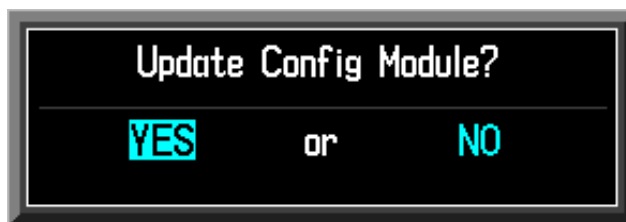
11. Press the UPDT CFG softkey.

12. Use the FMS knob to select YES.

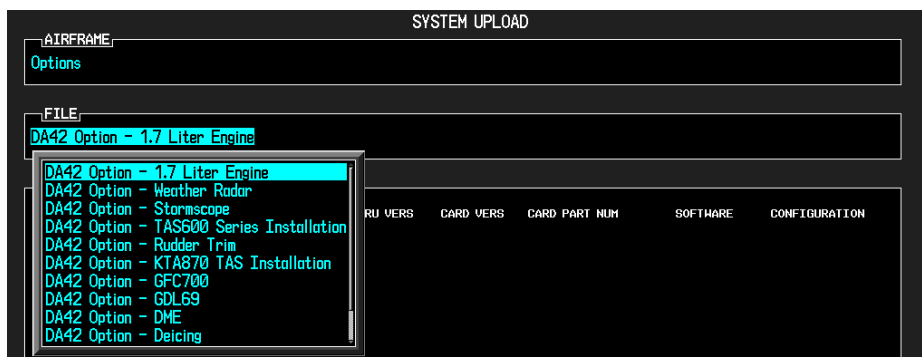
4. Press the ENT key.
5. Using the FMS knob select the appropriate option and press the ENT key.

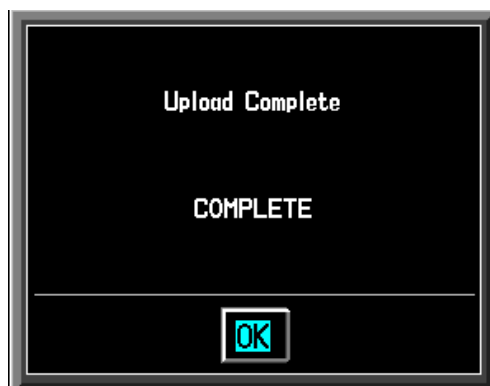
6. Press the CHK ALL softkey.
7. Press the LOAD softkey, to begin the software and configuration loading process.
8. Press the ENT key to acknowledge the Upload Complete prompt.

9. View the SUMMARY field and ensure that all items are "COMPLETED".
10. Repeat steps 5 through 8 to load any other equipped options.
11. Re-enter the configuration settings as noted in Section 2.2 Step 23 of this bulletin.
12. Refer to the DA 42 Airplane Maintenance Manual Section 31-40-00 for instructions on manually setting other configuration settings.
13. Once all software and configuration files have been loaded, proceed to Section 2.5 of this bulletin.

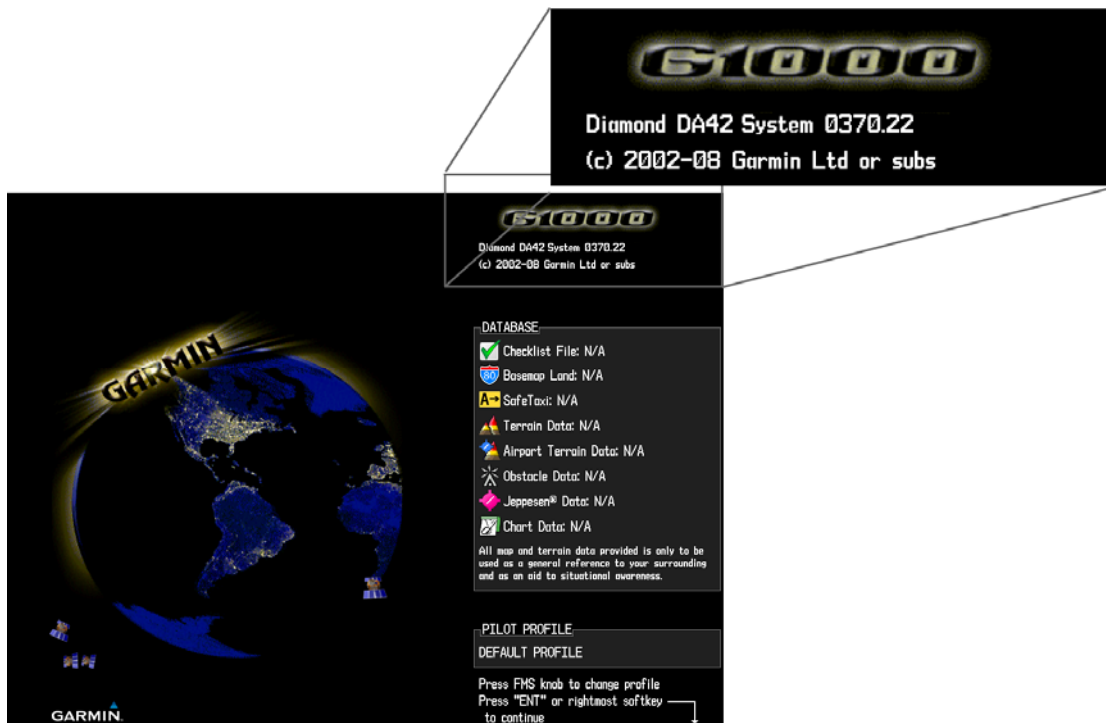
- Look at the upper right corner of the MFD power-up screen, the display shows 'Diamond DA42 System XXXX.XX':

- This 'System' number is the System Software Version. It correlates to the G1000 SW Loader Card used to load the software to the system:

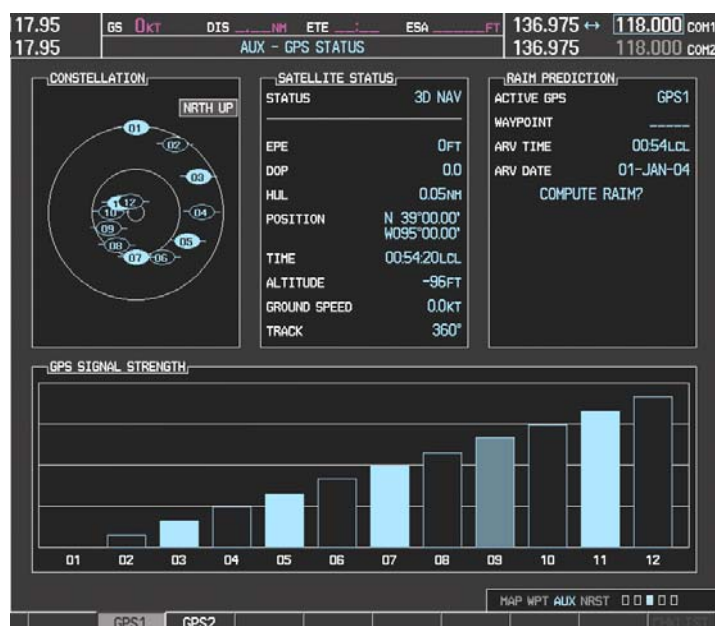
16. Verify that engine and airframe instruments are valid on the MFD.
17. Push the red DISPLAY BACKUP button on the GMA 1347. Verify both displays enter reversion mode: both should have valid attitude, altitude, airspeed, vertical speed, and engine instruments.

18. De-activate reversion mode by pushing the DISPLAY BACKUP button again.

19. The GIA 63 units should normally acquire a 3D GPS navigation solution within 5 to 10 minutes of startup, provided the aircraft is outside (or indoors with a GPS repeater). Select the AUX – GPS STATUS Page on the MFD. Two softkeys on the bottom of the display allow the user to toggle between GPS 1 and GPS 2. Verify that both receivers show 3D Navigation on the MFD.

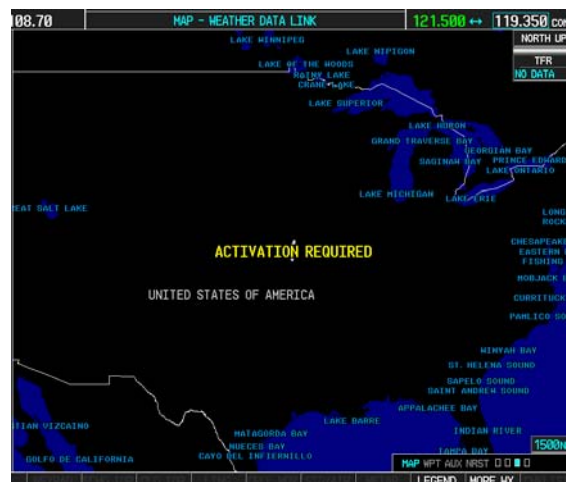
This check verifies that the GDL69-to-G1000 interface operates correctly. This check is required for DA42 aircraft with the GDL 69 installed.

1. Using the small FMS knob, verify the Map – Weather Data Link page can be displayed on the MFD.

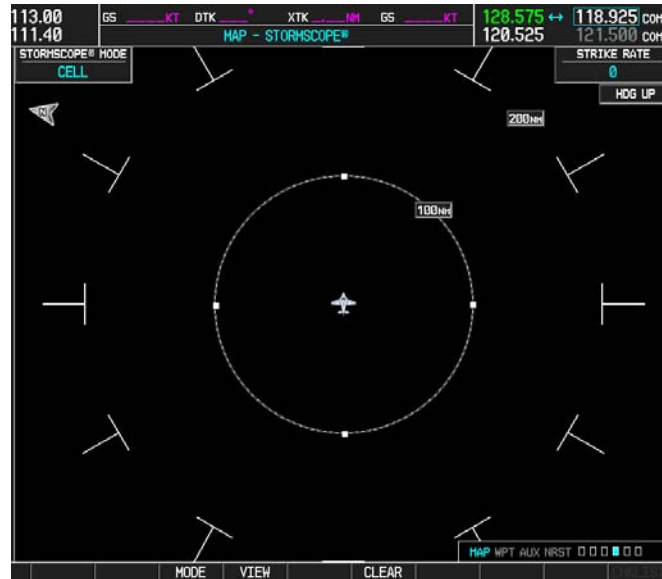
This check verifies that the L-3 Communications Stormscope interface operates correctly. This check is required for DA42 aircraft with the Stormscope installed.

1. Using the small FMS knob, verify the Map – Stormscope page can be displayed on the MFD.

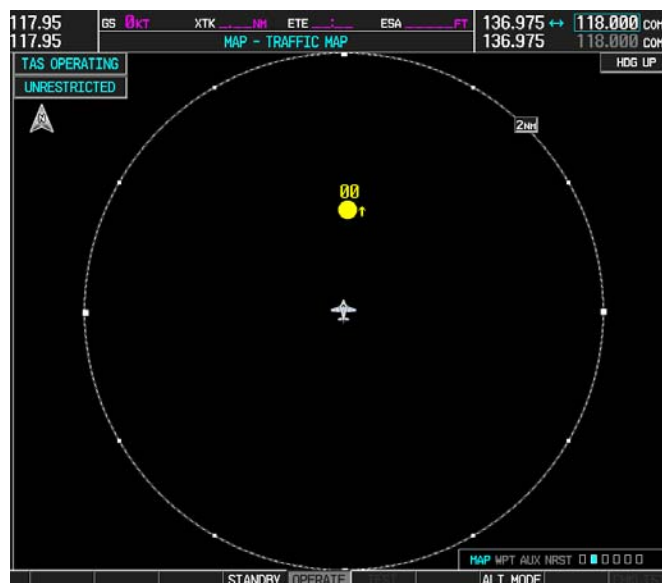
This check verifies that the KTA870 TAS-to-G1000 or TAS600-to-G1000 interface operates correctly. This check is required for DA42 aircraft with the KTA870 TAS or TAS600 installed.

1. Using the small FMS knob, verify that the upper left corner of the Map – Traffic Map page on the MFD displays "TAS OPERATING".

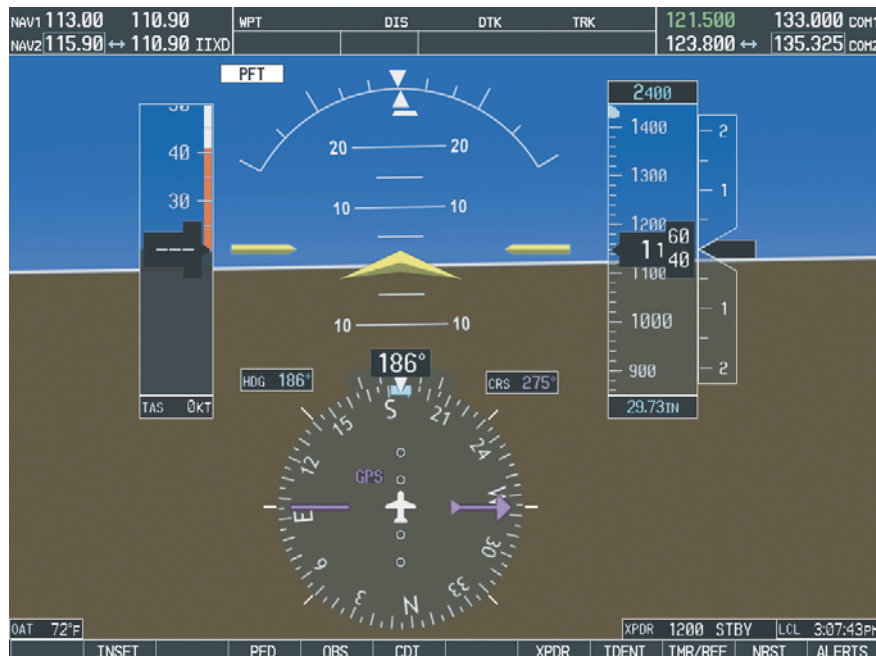
A red 'AFCS' (AFCS) annunciation will be displayed until both GIAs, the AHRS, and the autopilot servos are online. The red 'AFCS' annunciation will then be replaced by a white 'PFT' annunciation.

2. Verify that a white 'PFT' annunciation is displayed on the PFD, as shown in the following figure.
