SERVICE INFORMATION NO. SI20-040

All DV 20
Airplanes equipped with SL30 units.

ATA Code: 34
GARMIN Service Bulletin No. 0921 Rev. B

1.3 Reason

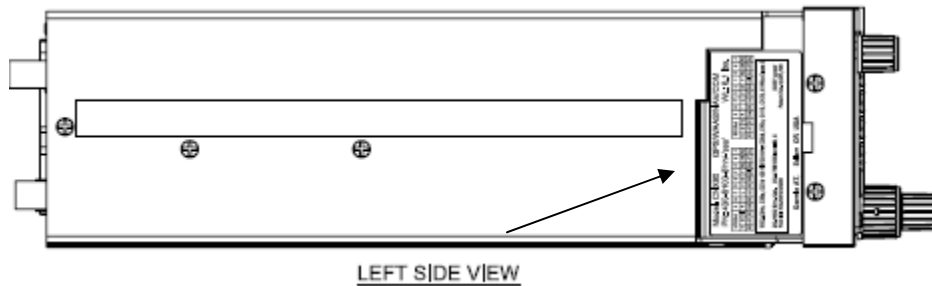
To identify the mod level of a GNS 480 (CNX80) unit:

Remove the unit and locate the nameplate on the left side of the unit. The hardware mod status is indicated in the block on the left side of the nameplate.

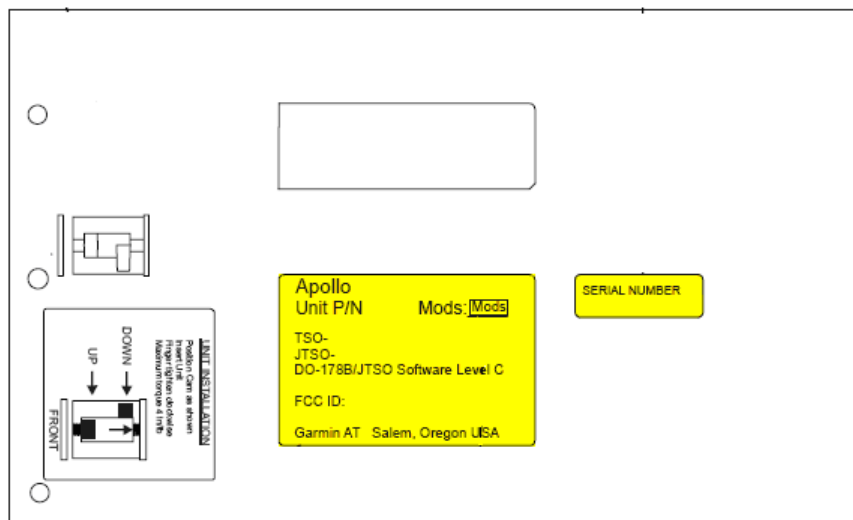
To identify the mod level of an SL30 or SL40 unit:

Remove the unit from the aircraft and locate the nameplate on the bottom side of the unit.
