## SERVICE INFORMATION NO. SI36-045

ATA Code: 34-00  
GARMIN Software Service Bulletin Nr. 0730  
Revision A

ATA Code: 34-00  
GARMIN Software Service Bulletin No. 0730  
Revision A

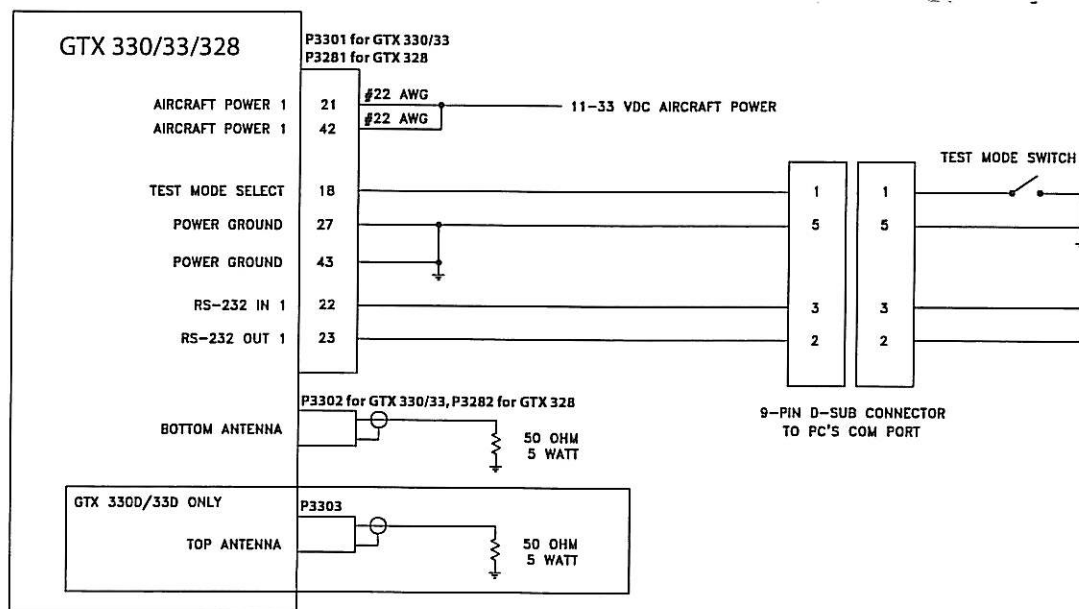
Figure 1

1. Use a test harness for the GTX 330/GTX 33/GTX 328 as shown in Figure 1.

If the unit is removed from the aircraft and operated, always connect J3302 for GTX 330/33 (and J3303 for GTX 330D/GTX 33D) or J3282 for GTX 328 units, to an antenna or a 50  $\Omega$ , 5-watt load. The GTX 330/GTX 33/GTX 328 transmits Mode S acquisition squitter replies once per second whether interrogations are received or not. Failure to connect a dummy load during this procedure will cause the transponder to fail.

2. Ensure that the unit is turned off. Connect the GTX 330/GTX 33/GTX 328 to the test harness and apply power to the harness.
3. With the unit off, enable test mode via the Test Mode Switch. (Applies a ground to P3301/P3281 pin 18).
