Diamond Aircraft Industries Inc.

SERVICE INFORMATION LETTER

MODEL DA 20-C1

SERVICE INFORMATION LETTER NO. SIL20C1-012

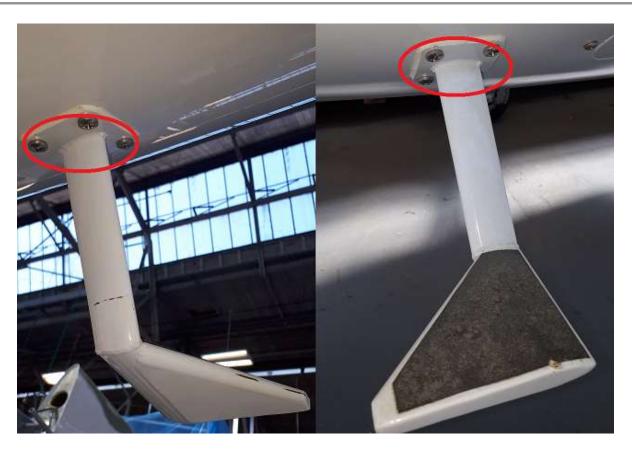
It was observed on a number of DA 20-C1 aircraft, that the step assemblies used to enter and exit the aircraft failed, and broke free of the aircraft as weight was applied to the steps.

Diamond Aircraft Industries recommends thoroughly checking the two step assemblies on either side of the fuselage for signs of corrosion, cracks, or other damage during the walk-around inspection, prior to entering the aircraft. Pay special attention to the areas highlighted in the figure below.
