RECOMMENDED SERVICE BULLETIN RSB 40NG-051

Type: DA 40 NG

Installation of a chafe protector on the turbocharger intake hose.

ATA-Code: 71-60

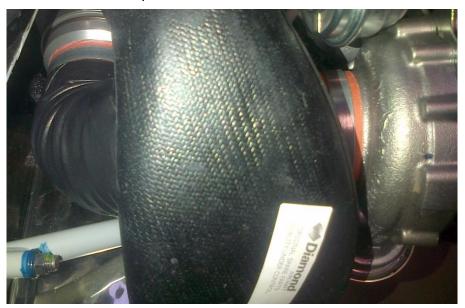
Slide the Intake Hose Chafe Protector D44-7166-00-70 centered on the turbocharger intake hose.

Install the turbocharger intake hose onto the alternate air valve and the turbocharger inlet.

- Connect the hose.
- Tighten the worm-drive-clamps.
