**MANDATORY SERVICE BULLETIN NO. MSB 40NG-066 REV. 2**  
**SUPERSEDES MSB 40NG-066 REV. 1**

Cowling lightning protection.

**WORK INSTRUCTION WI-MSB 40NG-066 REV. 1**  
**SUPERSEDES WI-MSB 40NG-066 REV. 0**

Installation of improved cowling lightning protection.

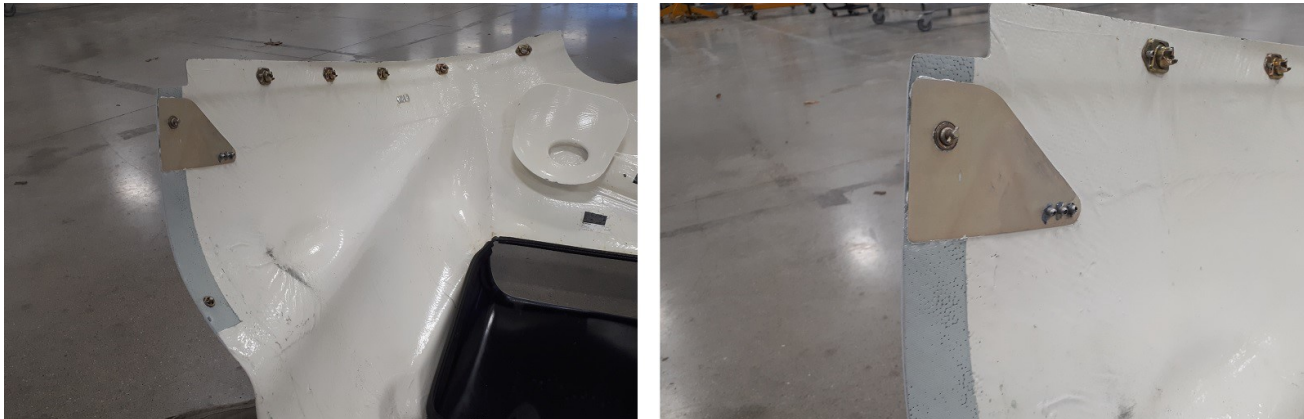
Figure 1. Left: position of item 1 on the left-hand side of the lower cowling. Right: zoomed view. Not shown: apply Nycote to the rivet shanks on the inside of the cowling after the sealant has cured (step 22).

1. Verify that the lightning protection has not been installed, and that OÄM 40-1015 has not been incorporated. If either of the above has been accomplished, no further work is required. Submit the execution report to Techpubs@diamondaircraft.com.
2. Align the camlock hole in the bonding strip (item 1) with the camlock hole in the lower cowling as shown in Figure 1.

3. Clamp item 1 to the cowling. Take care not to damage the paint on the cowling.
4. From the inside of the cowling, match drill rivet holes (4 mm diameter) in the cowl surface. Use a suitable drill bit.

5. Remove the clamps, and prepare item 1 for bonding:
  - A. Sand the inner surface of the cowling where item 1 will be bonded.
  - B. Sand the surface of item 1 that will be in contact with the cowling.
  - C. Apply Terostat MS 9380 WH to the sanded surface of item 1. Cover the surface completely.
  - D. Clamp item 1 to the cowling. Use multiple clamps to ensure sufficient contact. Take care not to damage the paint on cowling.
  - E. Install clecos into the three rivet holes from the outside in.
  - F. Allow 24 hours to cure.

22. Apply Nycote to the rivet shanks and the bonding strip on the inside of the cowling, to seal the connection between the rivets and the bonding strip.

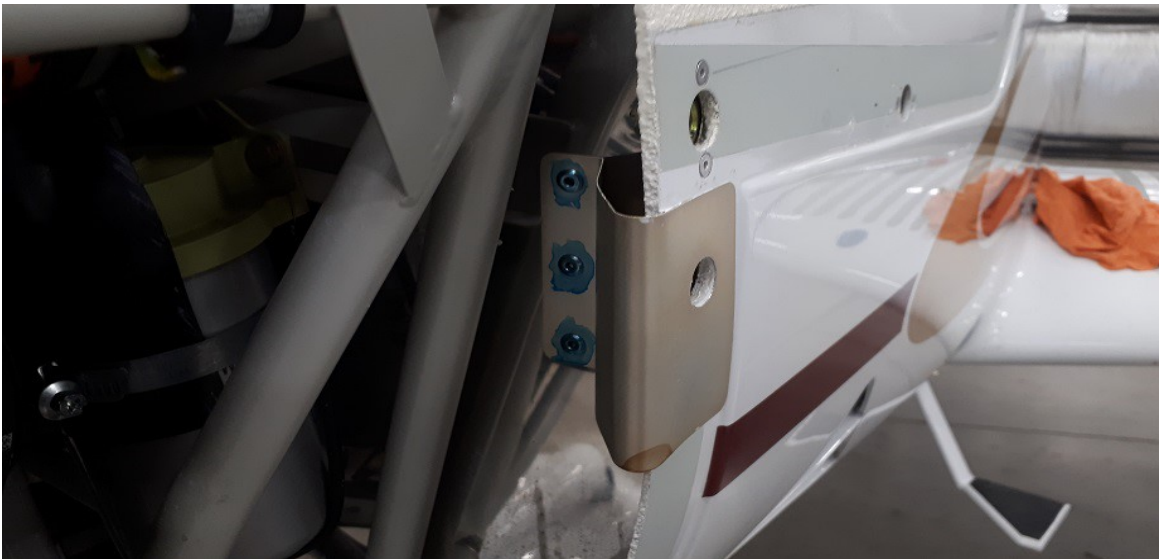
Figure 2. Position of item 3 on the left-hand side of the aircraft. Not shown: also apply Nycote around the edges of item 3 where it contacts the firewall (step 30).

6. Align the camlock hole in the bonding sheet (item 3) with the camlock hole in the fuselage as shown in Figure 2.

7. Clamp item 3 to the fuselage. Take care not to damage the paint on the fuselage.
8. Using a suitable drill bit and a 90° angle head drill, match drill item 3 to the firewall. The holes are 4 mm diameter.

9. Remove the clamps, and prepare item 3 for bonding:
  - A. Sand the inner surface of the cowling where item 3 will be bonded to the fuselage.
  - B. Sand the surface of item 3 that will be in contact with the fuselage.
  - C. Apply Terostat MS 9380 WH to the sanded surface of item 3. Cover the surface completely.
  - D. Clamp item 3 to the fuselage. Use multiple clamps to ensure sufficient contact. Take care not to damage the paint on the fuselage.
  - E. Install clecos into the three rivet holes.
  - F. Allow 24 hours to cure.

30. Apply Nycote to the rivet heads, and to the edges of item 3 that are in contact with the firewall, to seal the connections between the rivets, the bonding strip, and the firewall.

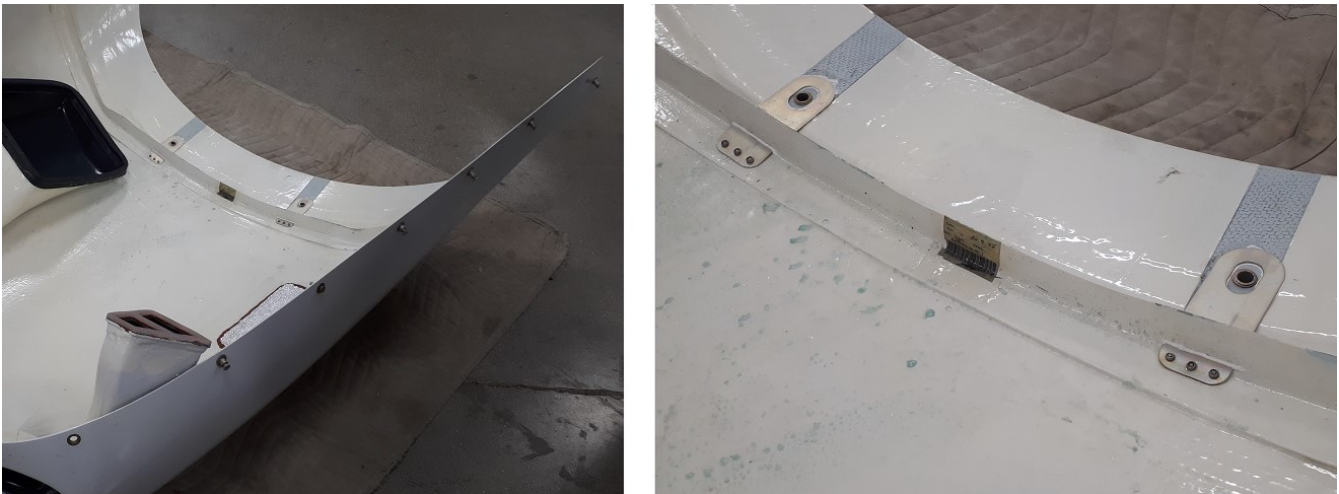
Figure 3. Left: installation of item 2 (x2) on the top cowling. Right: zoomed view. Not shown: apply Nycote to the rivet shanks on the inside of the cowling after the sealant has cured (step 38).

10. Using a suitable tool, cut a slot into the fire bulkhead to allow the installation of the cowling bonding strip (item 2). Keep the size of the slot to a minimum. See Figure 3.

11. Align the camlock hole in the bonding strip (item 2) with the camlock hole in the cowling as shown in Figure 3.
12. Clamp item 2 to the cowling. Take care not to damage the paint on the cowling.
13. From the inside of the cowling, match drill rivet holes (4 mm diameter) in the cowl surface. Use a suitable drill bit.

14. Remove the clamps, and prepare item 2 for bonding:
  - A. Sand the surface of the upper cowling that will be in contact with item 2.
  - B. Sand the surface of item 2 that will be in contact with the upper cowling.
  - C. Apply Terostat MS 9380 WH to the sanded surface of item 2. Cover the surface completely.
  - D. Position item 2 as shown in Figure 3.
  - E. Clamp item 2 to the upper cowling. Use multiple clamps to ensure sufficient contact. Take care not to damage the paint on the cowling.
  - F. Install clecos into the three rivet holes from the outside in.
  - G. Seal item 2 into the fire bulkhead using CS 1900 firewall sealant.
  - H. Allow 24 hours to cure.

37. Install countersunk rivets (item 6).
- NOTE:** make sure to keep the rivets perpendicular to the surface.
38. Apply Nycote to the rivet shanks on the inside of the cowling, to seal the connection between the rivets and the bonding strip.
  39. Repeat steps 37 and 38 for the other cowling bonding strip (item 2).
