MANDATORY SERVICE BULLETIN NO. MSB F4-039 REV. 0

Type: DA 40 F

Replacement of baggage nets with defective buckles.

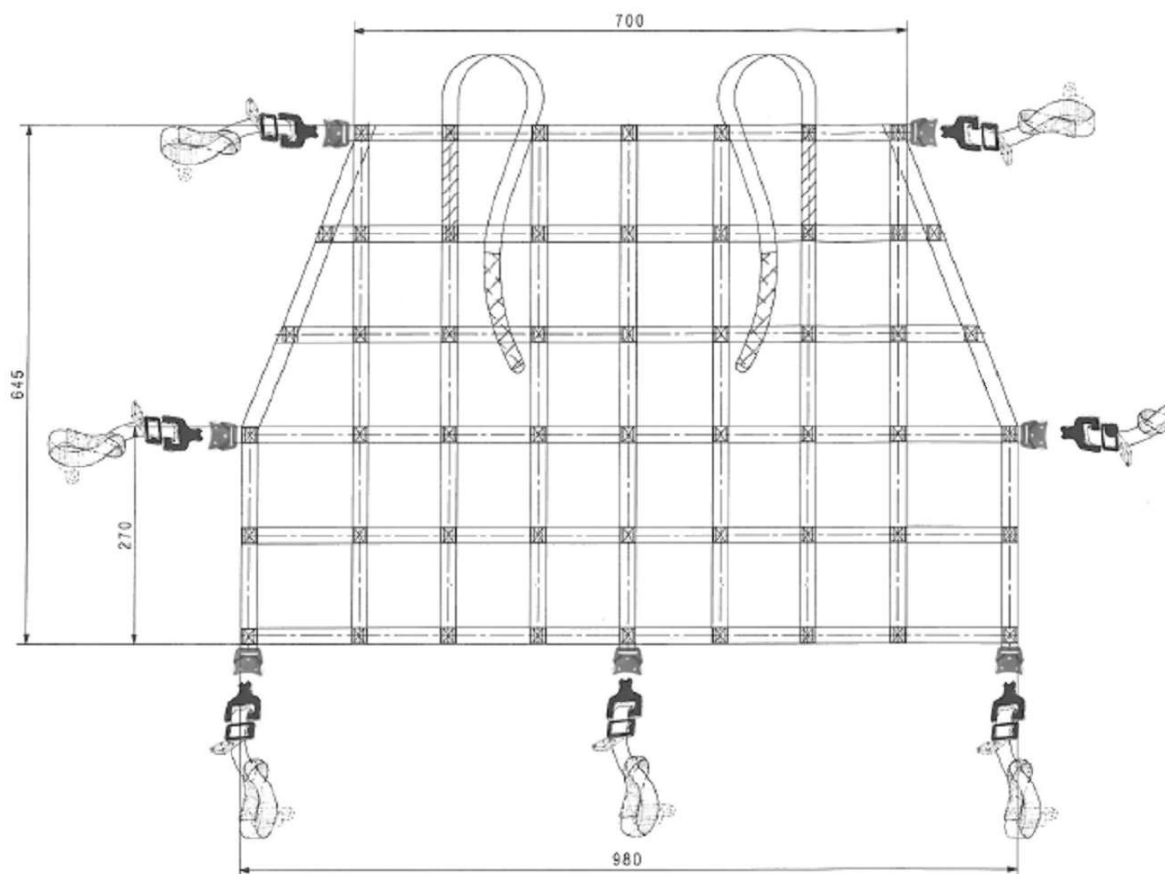
Figure 1 - Baggage net installation.

1. Refer to Section I.2. Identify if the baggage net in the aircraft is an affected net. Use the part number and date of manufacture to identify the net.
2. If an affected net is installed, clearly mark the currently installed net as defective, and remove it from the aircraft.

3. Destroy the removed baggage net, or return it to Diamond Aircraft Industries.
4. Install the new baggage net provided by Diamond Aircraft Industries.
