SERVICE INFORMATION NO. SI 42NG-033

Austro Engine Mandatory Service Bulletin MSB-E4-014/1
ATA-Code: 73-10

No. MSB-E4-014/1
SUPERSEDES MSB No. MSB-E4-014

Replacement of the Fuel Return Line and Banjo Fitting

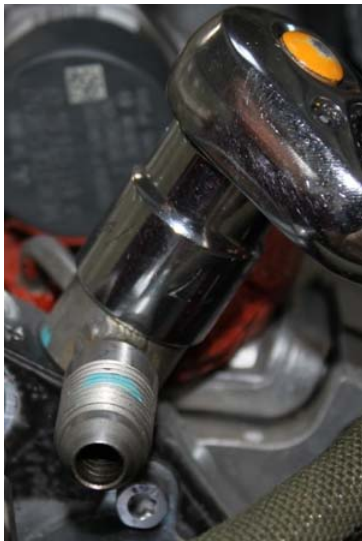
Step 3

Disconnect the Banjo Fitting [1].

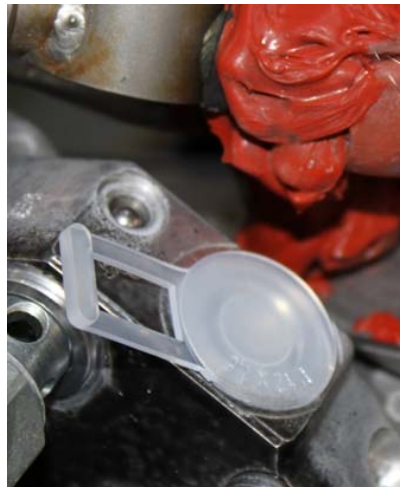
Step 4

Plug the High Pressure Pump outlet to avoid contamination of the fuel system.

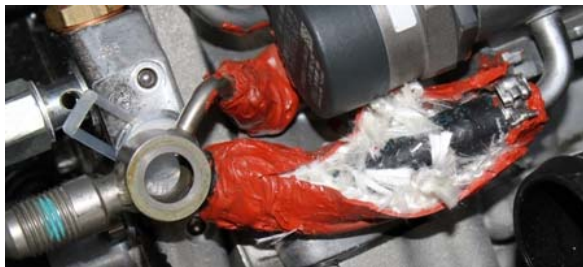
Step 5

Disconnect the Rail Return Line [3].

Take care not damaging the Rail Return Line while demounting the fire sleeve. The Rail Return Line including Clamps need to be reinstalled.

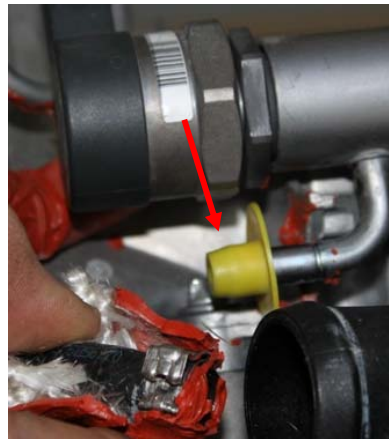
Step 6

Plug the Rail outlet to avoid contamination of the fuel system.

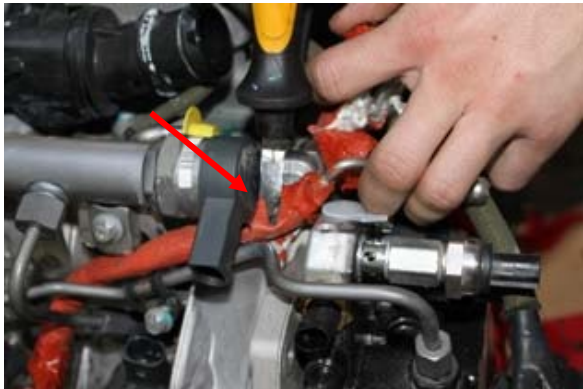
Step 7

It is possible to cut the Injector Return Line [2] for an easier disassembly.

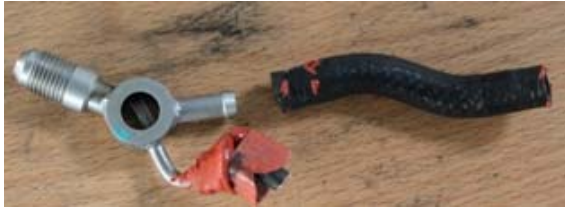
Step 9

Disassemble the Rail Return Line [3] from the old Banjo Fitting [1] and clean them from remaining sealant and fire sleeve.

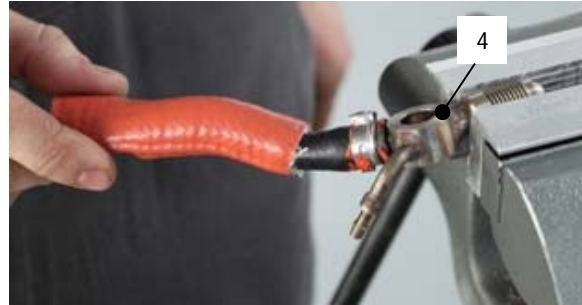
Step 10

Take the new Banjo Fitting [4] and assemble them with the Rail Return Line [3], clamp and new fire sleeve.

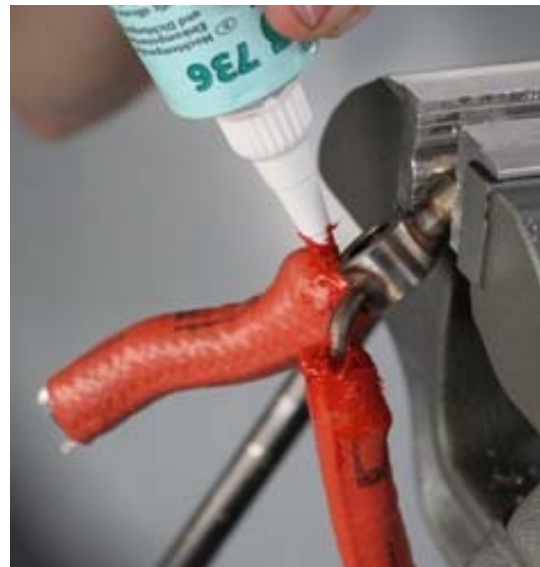
Step 12

Use sealant (for material specification see chapter 3.1) to insolate the fire sleeve ends.

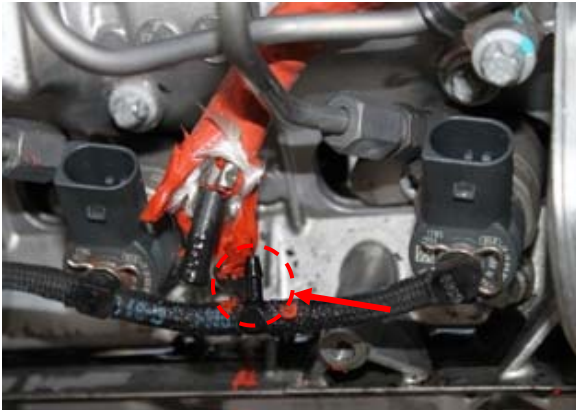
Step 13

Disassemble the Injector Return Line [2].

Take care **not** damaging the connector.

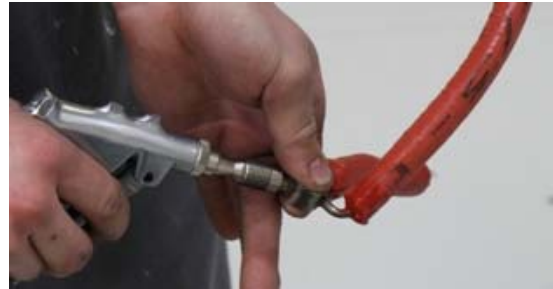
Step 14

Before assembly blast the preassembly to avoid contamination of the fuel system.

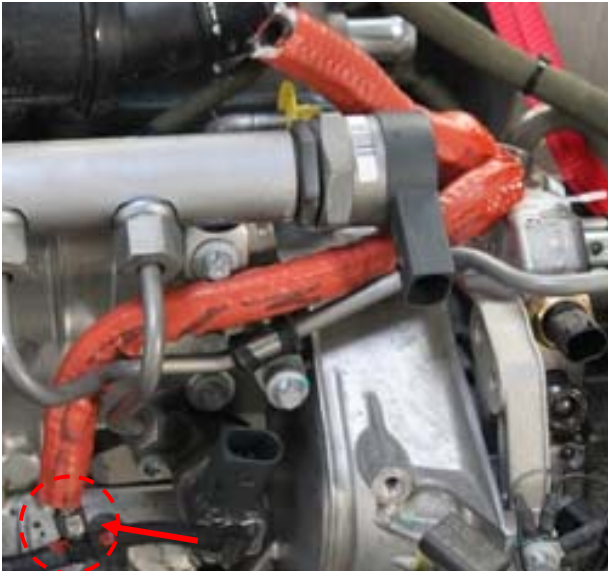
Step 15

Route the hose as shown and connect the Injector Return Line [5] with new clamp.

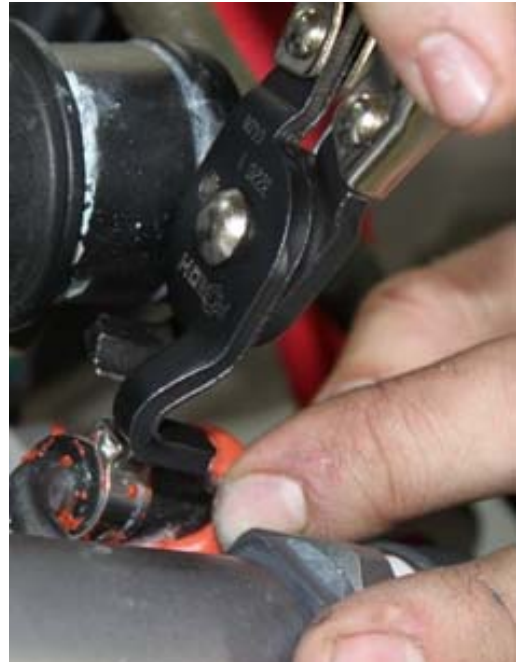
Step 16

Connect the Rail Return Line [3] to the Rail outlet using clamp tool.

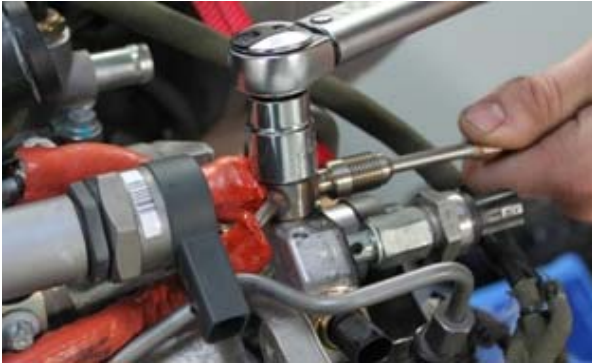
Step 17

Torque the Banjo Fitting [4] with the Banjo Bolt with 25Nm.

Do not forget to use two new washers.

4. For final installation refer to Maintenance Manual E4.08.04 chapter 85-00-12 – *“Installation of Injector Cover”*.
5. After engine ground run (which is part of scheduled maintenance procedure) torque the Banjo Bolt again with 25Nm.

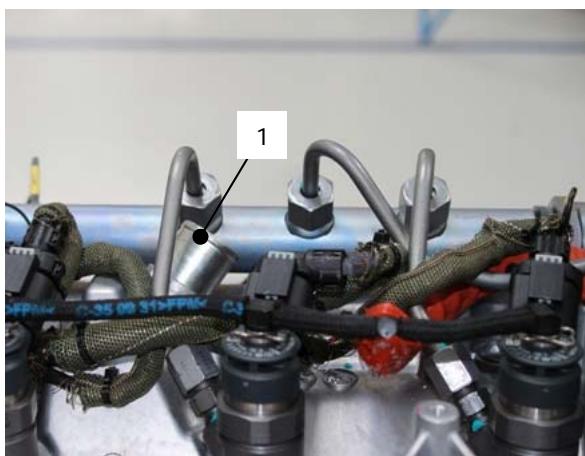
Step 20

Clean hose connection [1] on the cylinder head cover by using a dry and clean rag only.

Do not use any detergent to avoid engine oil contamination.

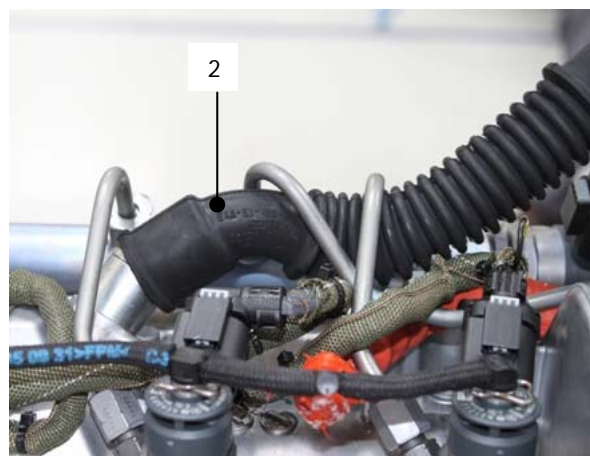
Step 21

Guide the oil separator hose [2] beneath the high pressure fuel lines as shown.

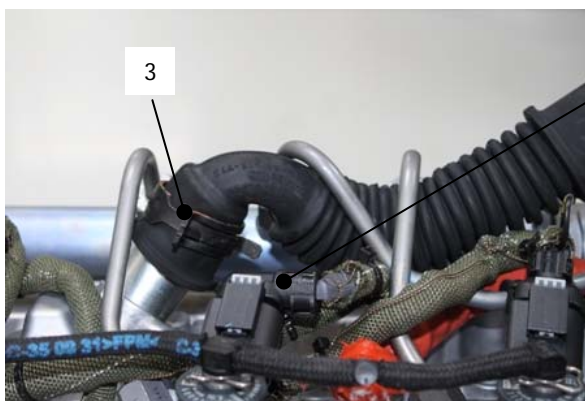
Step 22

Preassemble the hose clamp [3] to the oil separator hose as shown.

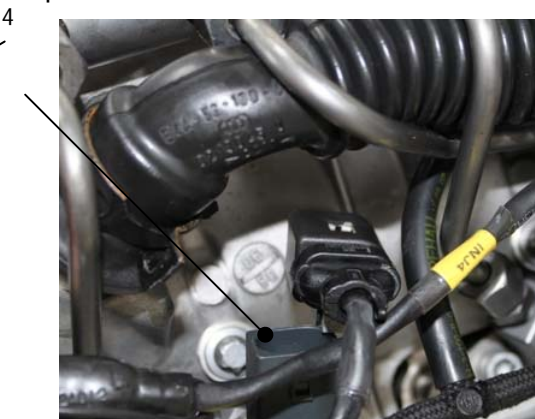
Step 23

Disconnect the injector plug [4] for an easier mounting of the oil separator hose, if required.

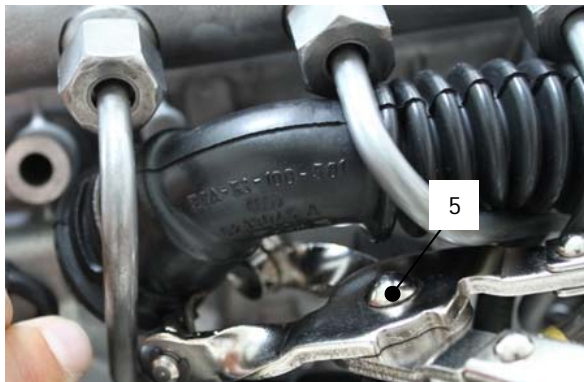
Step 24

Push the oil separator hose [2] over the hose connection [1] and fix it with the hose clamps [3].

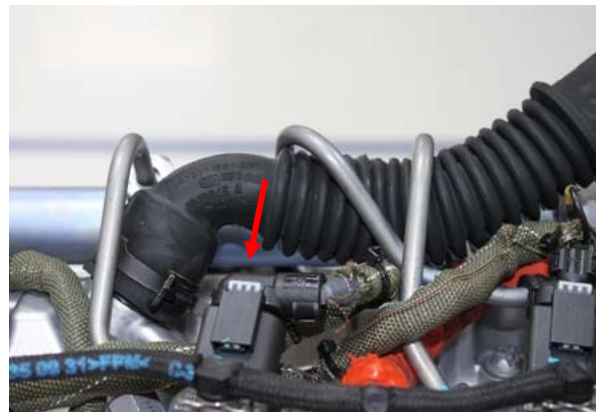
Step 25

Do not forget to reassemble the injector plug [4].

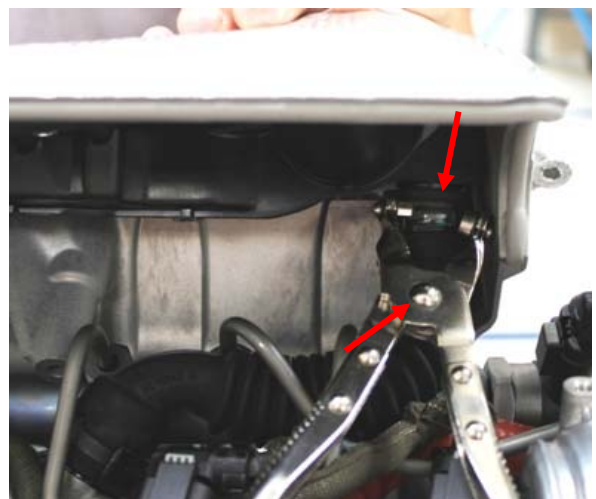
Step 27: In case the oil separator hose has been disassembled from the oil separator assembly:

Push the oil separator hose [2] on to the oil separator assembly [6] and fix them with the hose clamps [3].

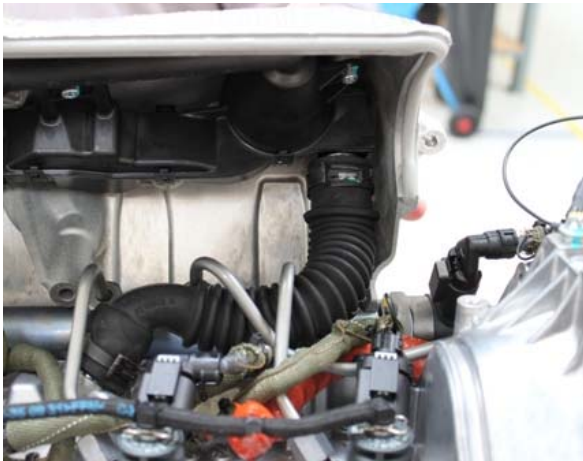
Step 28

Please take care during the oil separator hose installation that the hose is not stressed by torsion.

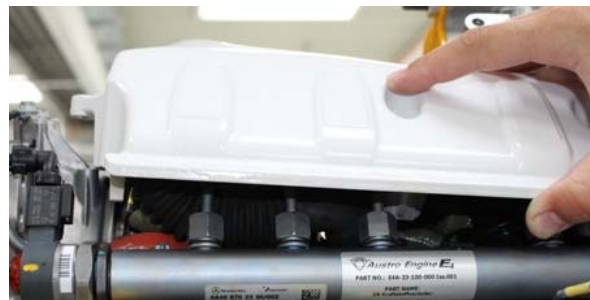
Step 29

Close the injector cover carefully to avoid stress to or jamming of the oil separator hose.

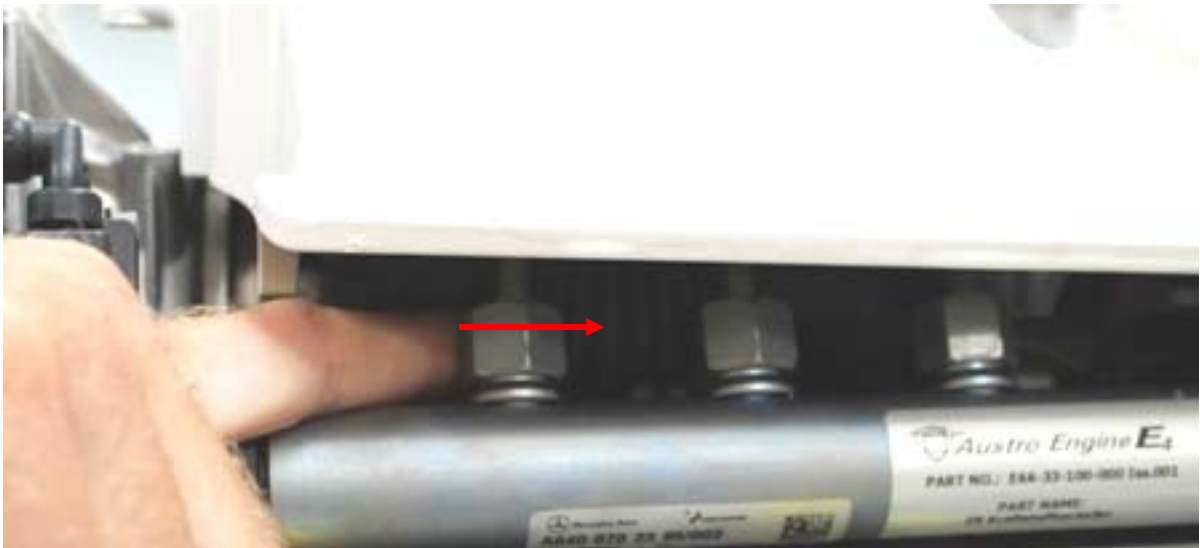
Step 30

Before mounting of the injector cover slightly push the hose towards the direction shown. This helps to avoid jamming of the oil separator hose.
