RECOMMENDED SERVICE BULLETIN

RSB 42-089/1

RSB 42NG-017/1

Replacement of seals in main landing gear damper.
ATA-Code: 32-10

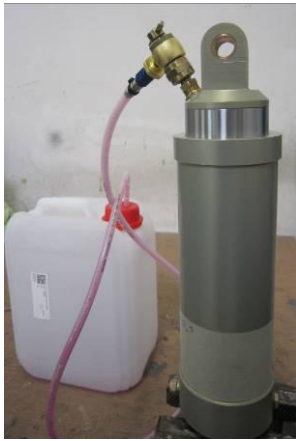
<p>Picture1</p> </div>
4	Remove the charging valve from damper.
5	<p>Remove the bottom cap:</p> <ul style="list-style-type: none"> • Remove the bolt holding the bottom cap. • Pull the bottom cap from the damper assembly.

1	Ensure AMM-TR-MÄM-42-368 is incorporated into the AMM.
2	Remove the Main Landing Gear Damper acc. to AMM section 32-10.
3	<p>Release nitrogen and oil from the damper.</p> <p>WARNING: Do not spill Fluid 41 on your skin or on your clothes. Fluid 41 is harmful and can cause skin disease and damage to clothes.</p> <p>WARNING: The damper is gas loaded. Always wear safety glasses.</p> <p>Install the adapter with drain hose onto the charging valve of the damper and release the pressure into the suitable container acc. to picture 1.</p> <p>Wait until the nitrogen is fully released. Push in the damper to minimum position to drain the oil.</p> <div style="text-align: center;">

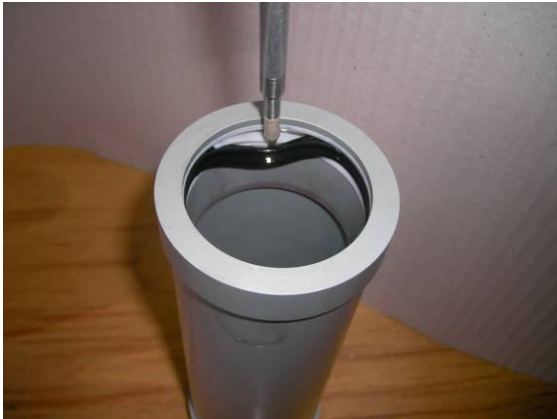
</div> <p style="text-align: center;">Picture 2</p>

9	<p>Remove the quad ring and the two backup rings from the tube:</p> <p>Caution: Do not use steel tools when removing the quad ring. Do not scratch the surfaces of the groove.</p> <p>Use seal pick D60-3277-10-01-ST to remove the quad ring. Clean the cylinder tube with acetone. Examine the grooves of the cylinder tube and the piston tube for scratches and wear. If scratch and wear are discernible, replace the defective part.</p> <div data-bbox="547 1543 1106 1960" data-label="Image">

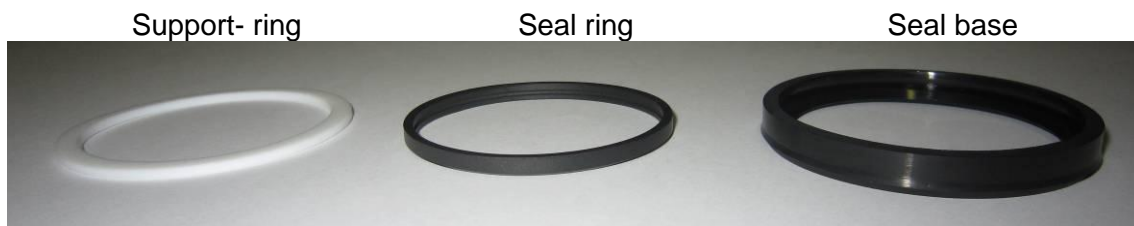
Picture 3

Description of the new tandem seal kit in the cylinder tube:

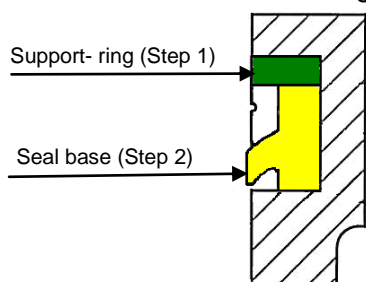
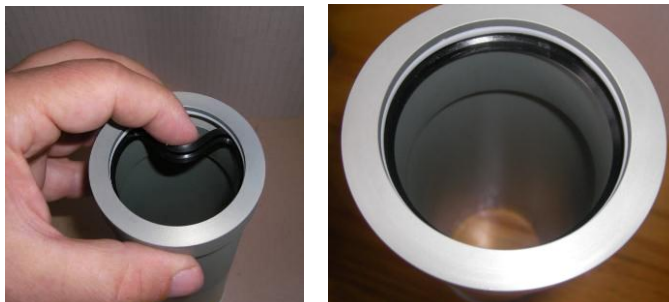
Picture 5

Install the seal base below the support ring:

Deform the seal base acc. to picture 5 and install it in the cylinder tube.
Press the seal base into the groove.

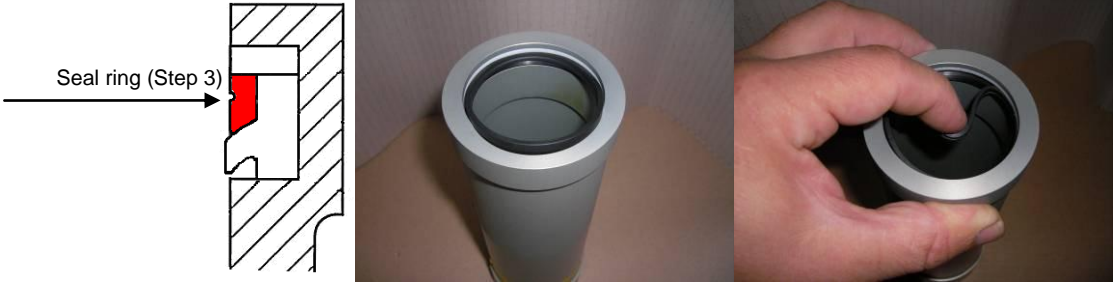
13	<p>Install the seal ring into the seal base. Deform the seal ring acc. to picture 6 and install it into the cylinder tube.</p> <p>CAUTION: Avoid excessive bending of the seal ring. Do not crack the seal ring.</p> <p>Press the seal ring into the seal base groove.</p>

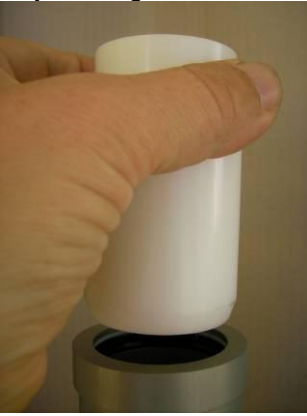
<p style="text-align: center;">Picture 7</p>
16	<p>Examine the connection of the thread rod and upper cap for tight fit. If necessary: Apply Loctite 262 to thread and retighten nut.</p>
17	<p>Install the piston tube on the piston tube end acc. to picture 8. Ensure tight fit.</p>

<p style="text-align: center;">Picture 6</p>
14	<p>Apply a coat of Additive 1U-9891 on the tandem seal kit and the centering pin.</p>
15	<p>Carefully insert the centering pin X00-W027-00-00.01 into the cylinder tube 2 or 3 times to position the tandem seal in the cylinder groove.</p>

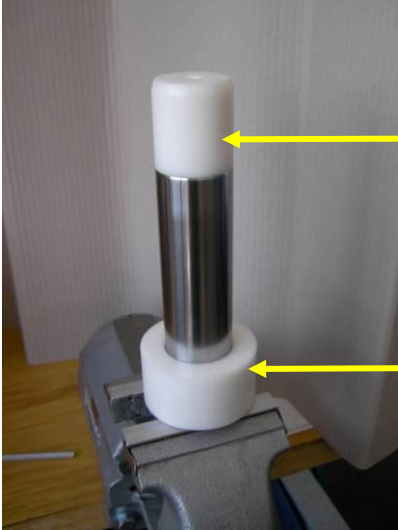
<p style="text-align: center;">Picture 9</p>
19	<p>Apply a coat of Additiv 1U-9891 on the piston tube and the centering pin.</p>
20	<p>Put the cylinder tube over the centering pin on the piston tube.</p>
21	<p>Remove the centering pin with a M12 bolt.</p>

18	<p>Mount the spacer and the centering pin acc. to picture 9.</p>

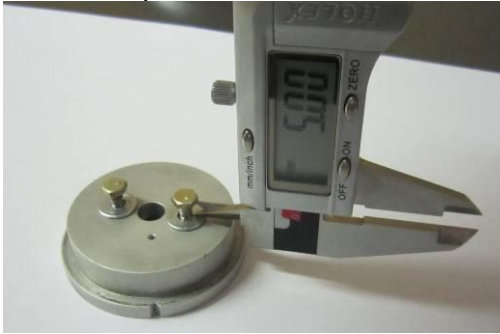
<p style="text-align: center;">Picture 11</p>
23	<p>If adjustment is necessary: Remove the bolt and apply a coat of Loctite 262 to the thread and adjust a thread excess length of 5 mm between bolt head and restriction washer acc. to picture 11.</p>

<p style="text-align: center;">Picture 10</p>
22	<p>Examine the piston end plate: Check the thread excess length of 5 mm between bolt head and restriction washer acc. to picture 11.</p>

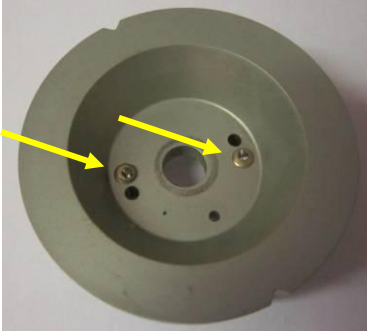
<p style="text-align: center;">Picture 12</p>
25	<p>Install the piston end plate in the cylinder tube with a nut LN 9348 M8. Secure the connection with Loctite 262 acc. to drawing D60-3277-10-00_01.</p>

24	<p>Secure the bolt after installation with a prick-punch on the bottom side acc. to picture 12.</p>

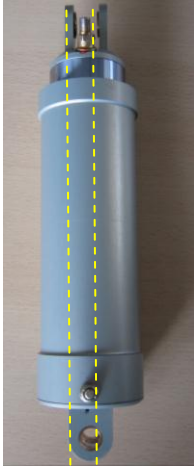
29	<p>Adjust the direction of the piston tube to the cylinder tube acc. to picture 14.</p> <p>Note: The charging valve must be aligned with the nut from the bolt holding the bottom cap.</p>

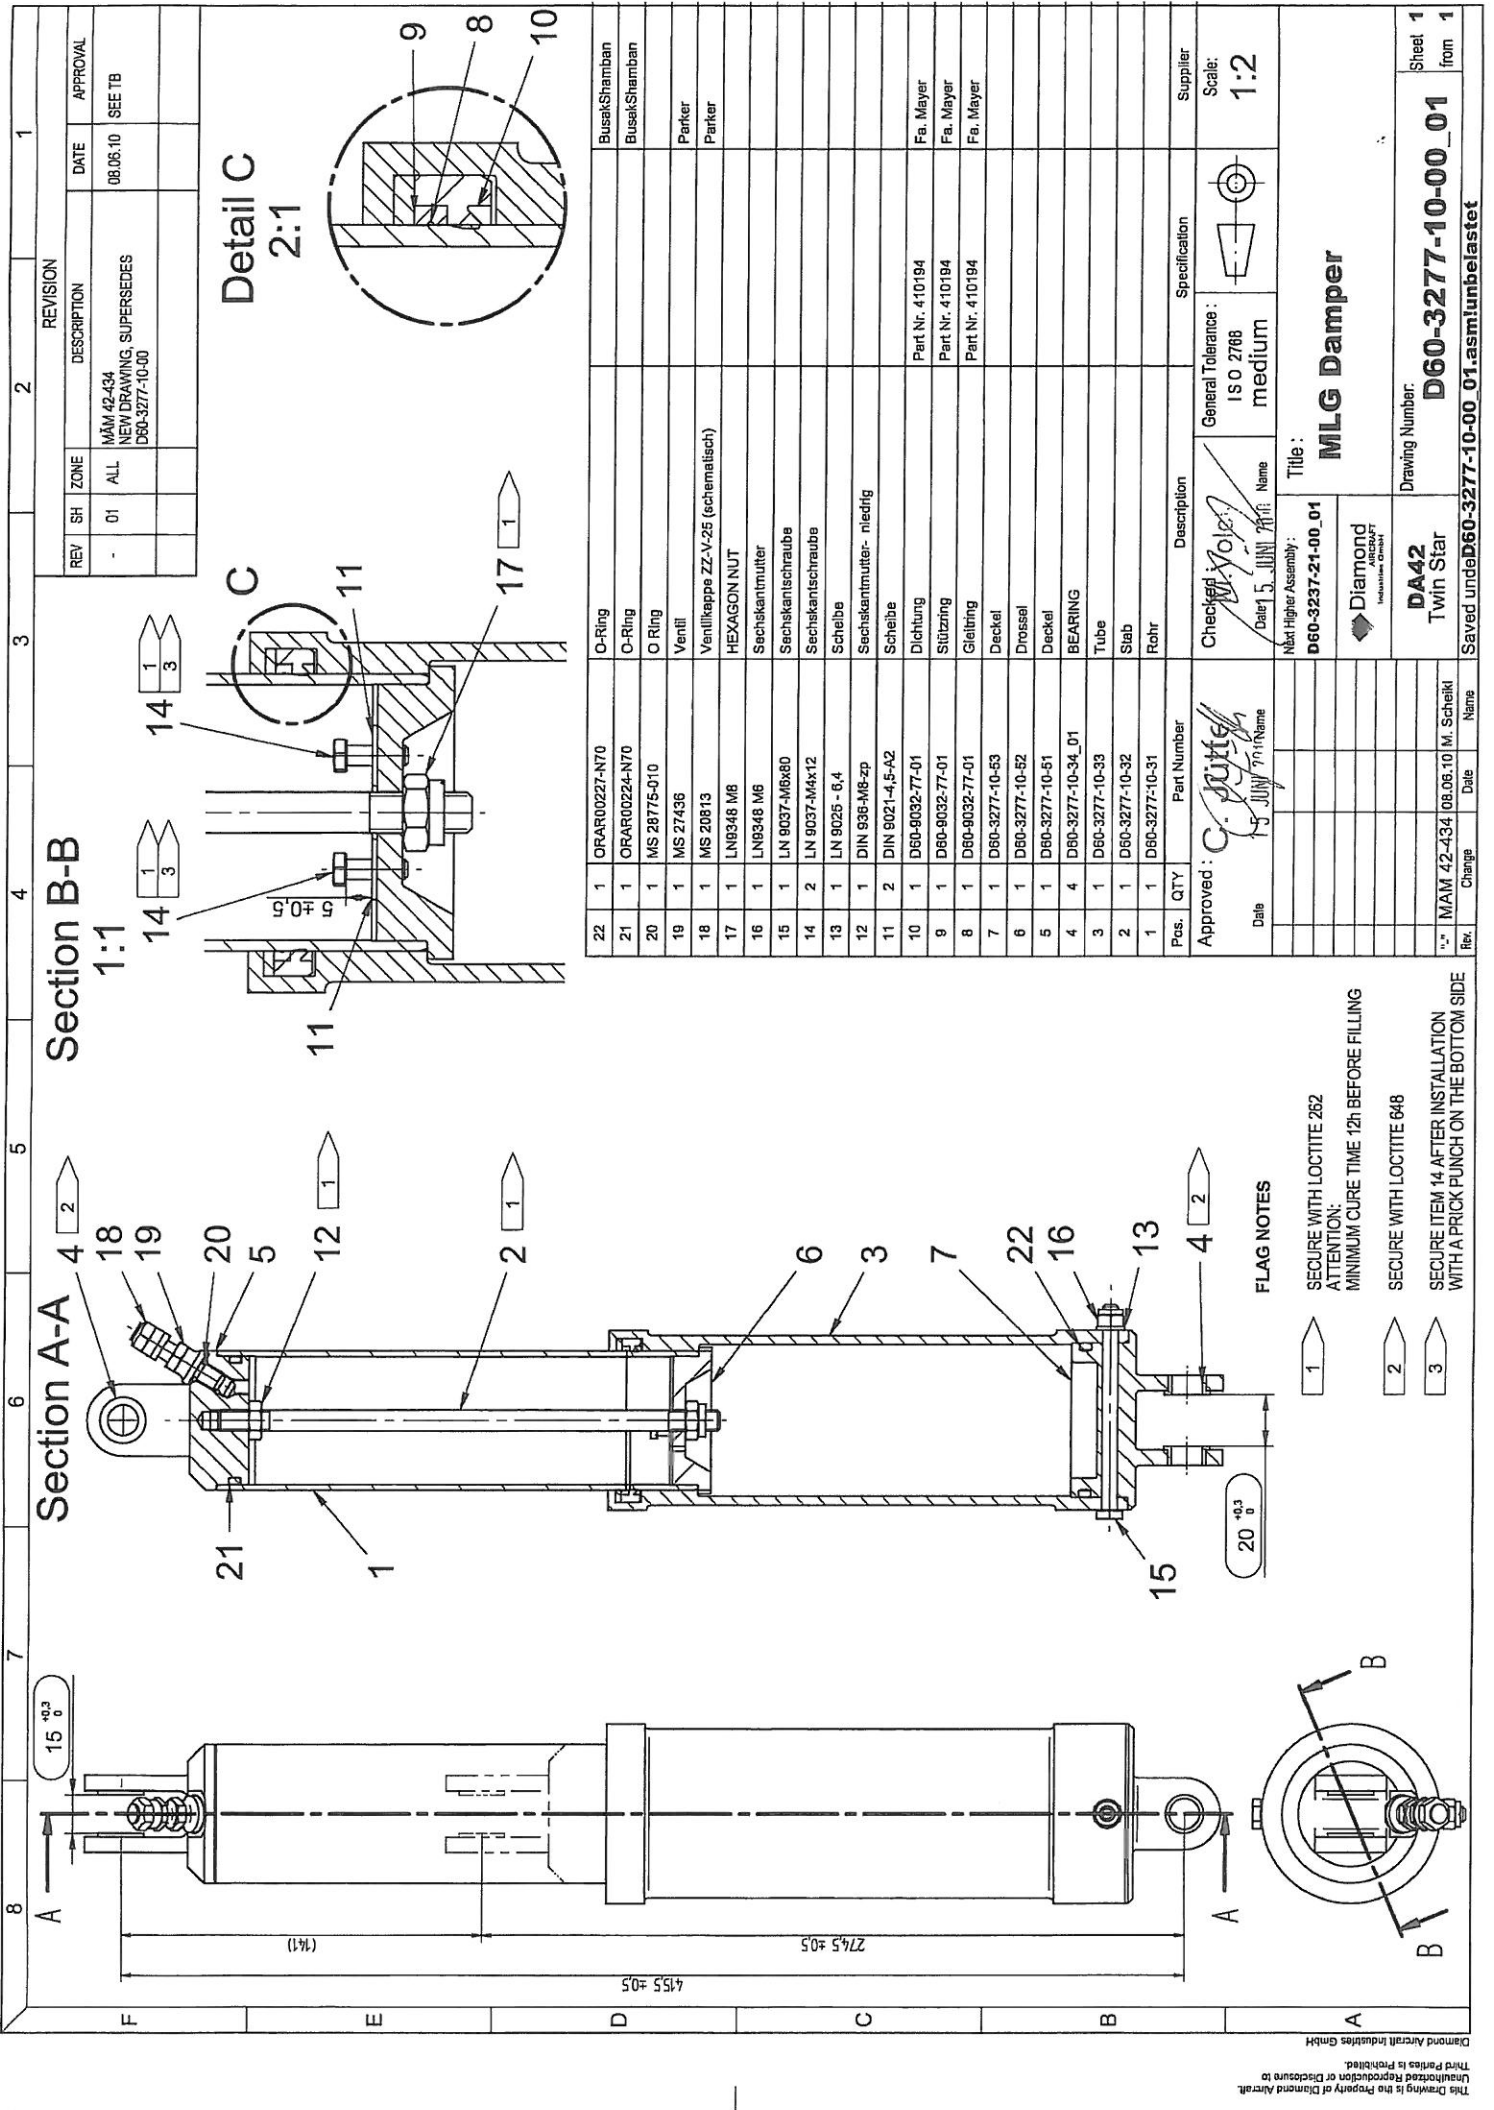
Drawing Number:
D60-3277-10-00_01

Title:
MLG Damper

- 1 SECURE WITH LOCTITE 262
ATTENTION:
MINIMUM CURE TIME 12h BEFORE FILLING
- 2 SECURE WITH LOCTITE 648
- 3 SECURE ITEM 14 AFTER INSTALLATION
WITH A PRICK PUNCH ON THE BOTTOM SIDE
