**SERVICE INFORMATION LETTER NO. SI62-018**

Aircraft: DA 62

Fuel hose labeled with incorrect P/N

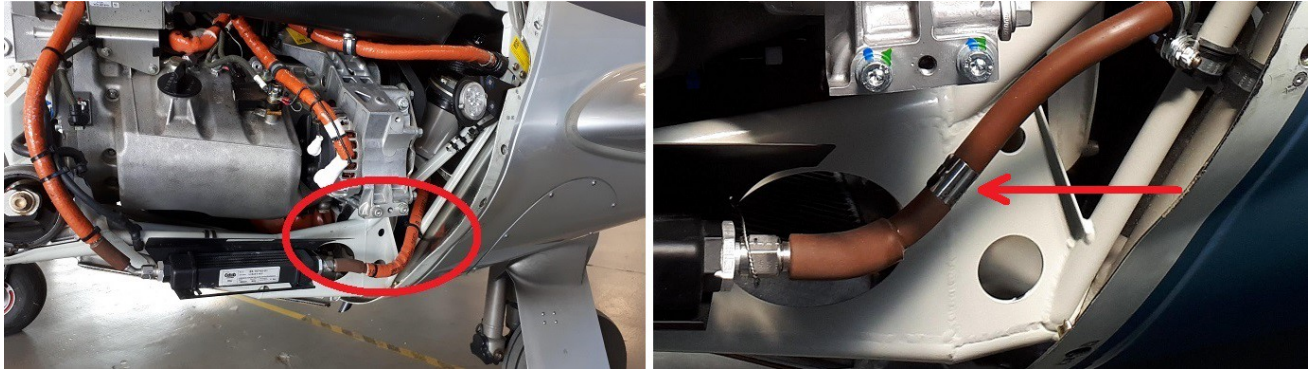
It has come to DAI's attention during maintenance actions that some DA 62 airplanes may have fuel hoses labeled with an incorrect part number. The hose in question is located on the left hand side of the engine, and runs to the fuel cooler from the firewall; see the figures that follow.

Figure 1: Left - location of fuel hose. Note the orange protective sleeve around the hose. Right - fuel hose without protective sleeve, see metallic band for the hose's part number.

The fuel hose shown in Figure 1, below, may be labeled with an incorrect part number. The correct part number for the hose is A24481-02, as shown in Figure 2. Some DA 62 airplanes may have hoses labeled incorrectly with a part number of A24481-01. If the fuel hose shown in the figures needs to be replaced, make sure to order and install the correct hose, part number A24481-02.

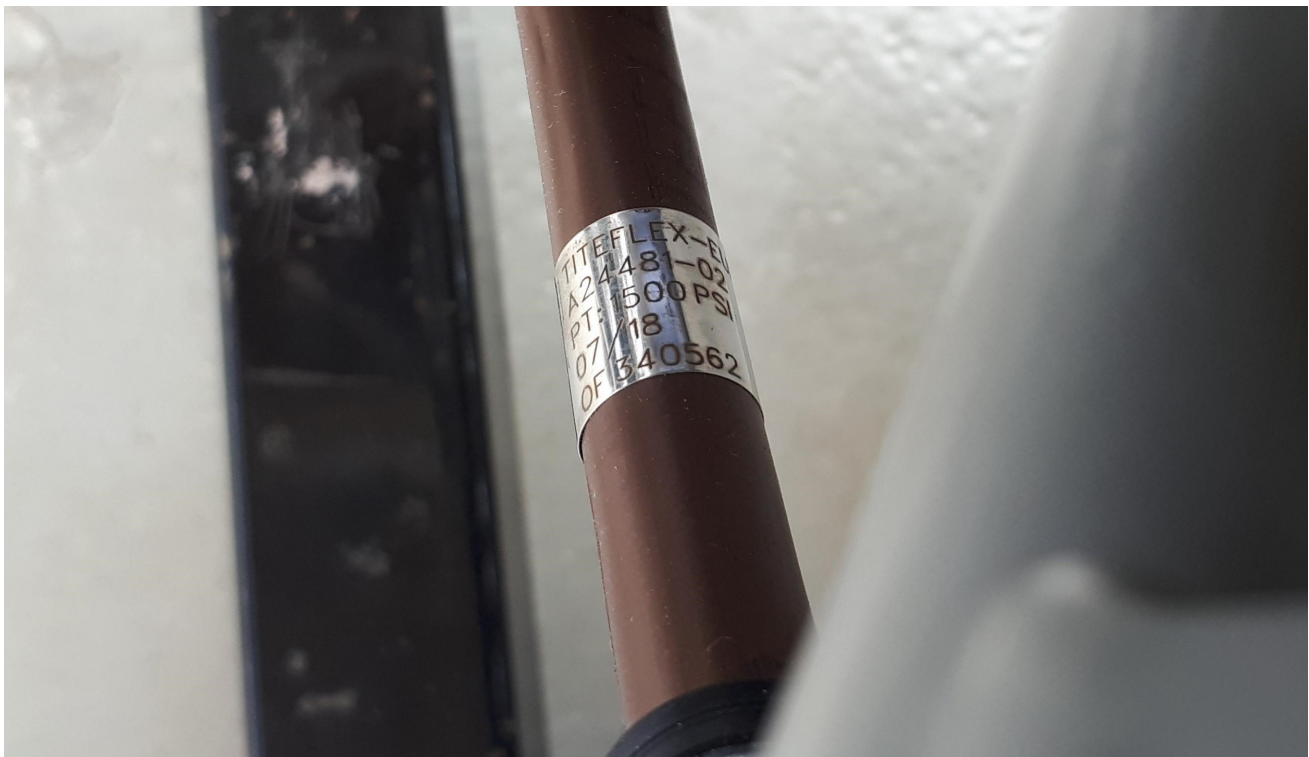
Figure 2: Fuel hose with correct part number A24481-02 (second line from top).
