SERVICE INFORMATION LETTER NO. SI62-024

Aircraft: DA 62

Installation of vented access panels

ATA code: 57-40

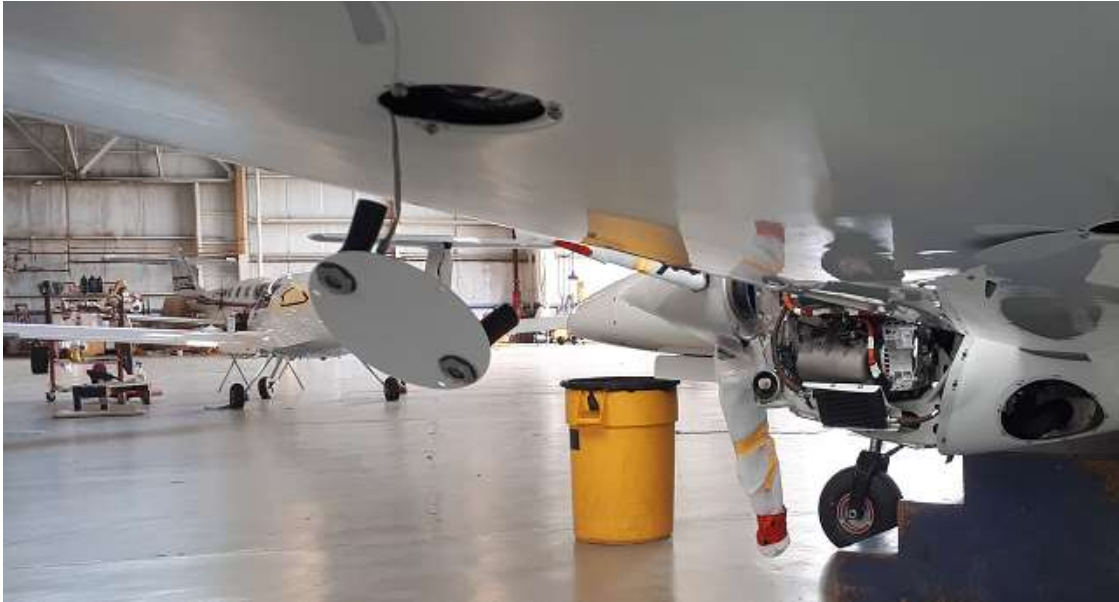
It has come to Diamond's attention that some operators have experienced difficulty installing the vented access panels (Figure 1) on the bottom surface of the DA 62's wings. This service letter has been issued to highlight the importance of ensuring the vent tubes attached to the access panel are not kinked, or obstructed, and properly fit around vent tubes inside the wing.

WARNING: FAILURE TO ENSURE THE VENT TUBES ARE UNOBSTRUCTED AND NOT KINKED MAY RESULT IN FUEL STARVATION OR FUEL TANK COLLAPSE.

Figure 1. Vented access panel on the bottom of the wing.

When installing the access panel, ensure the ends of the vent tubes attached to the access panel are circular. The ends may be warmed and worked by hand to ensure they are circular. The access panel may also be removed entirely from the aircraft, and the ends of the tubes may be placed in warm water to facilitate reshaping of the tubes to be circular. **DO NOT USE A HOT AIR GUN.** If the access panel is removed, ensure the bonding strap is reattached.
