Diamond Aircraft Industries Inc.

SERVICE INFORMATION LETTER

SERVICE INFORMATION LETTER NO. SI62-043

Improved Routing of Cabin Heat Bowden Cable.

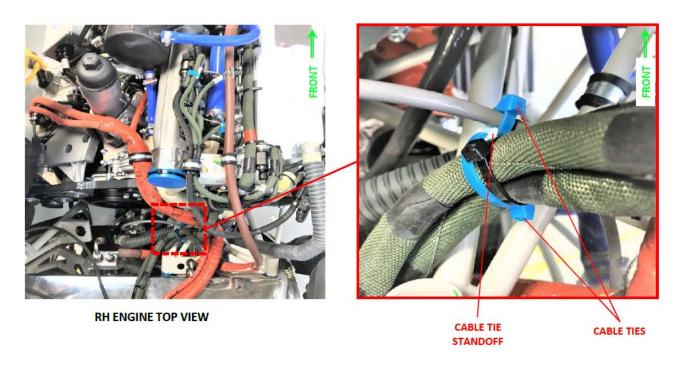
The purpose of this Service Information Letter is to inform owners and operators about the improved routing of the RH engine cabin heat bowden cable. This new routing prevents the cable from moving and touching the crank pulley, which can damage the cabin heat bowden cable.

- 1. Locate the cabin heat bowden cable and proceed to the next recommended step.
- 2. Secure the RH engine cabin heat bowden cable to the wiring harness using standoff cable tie mounts and cable ties. Refer to Figure 1.

NOTE: Make sure that the cabin heat bowden cable cannot touch engine belts or pulleys.

NOTE: Make sure that the cabin heat bowden cable is moving freely and reaching full open and closed positions.
